16 Cross street

11.12.21

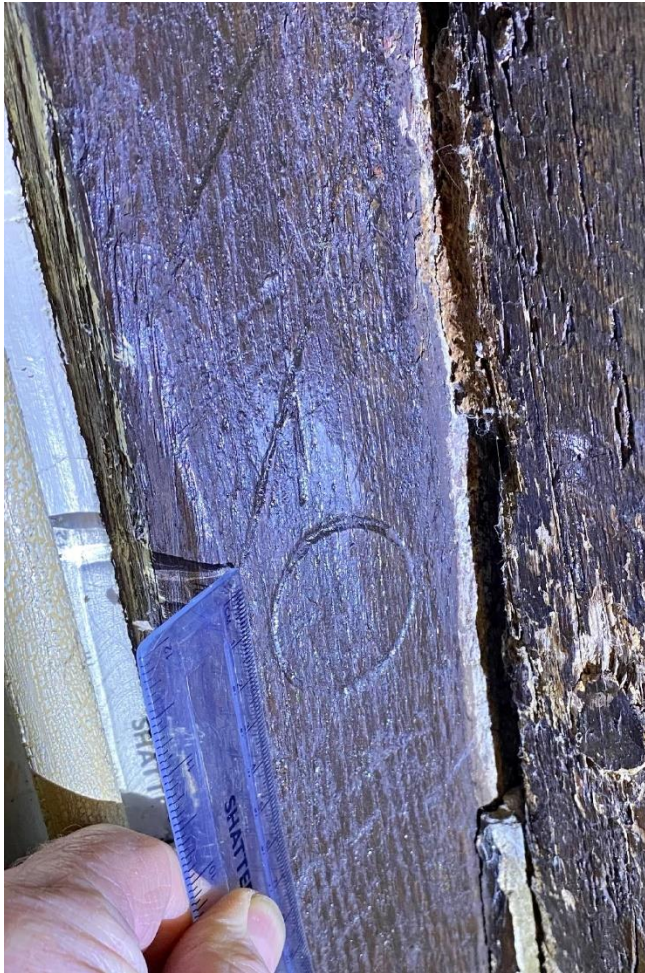
This 16th century timber framed two storey house was converted to a lobby entrance house in the 17th century by building a back-to-back chimney stack in the high-end bay of the hall against the hall's centre truss C as shown above.

Beams have mainly been painted over with brown paint which may obscure marks. There is an older ceiling in the loft which was not inspected.

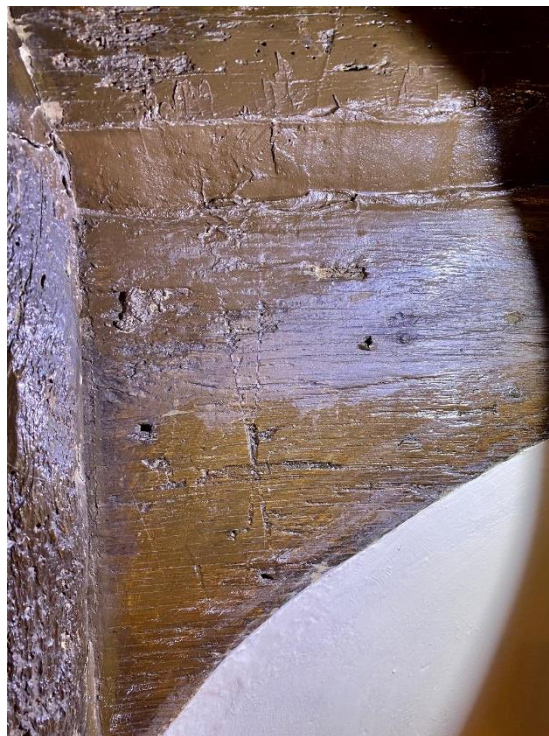
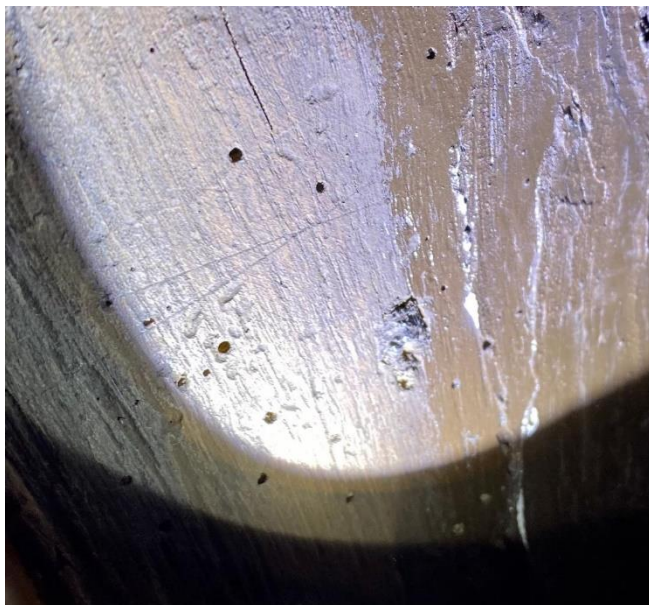
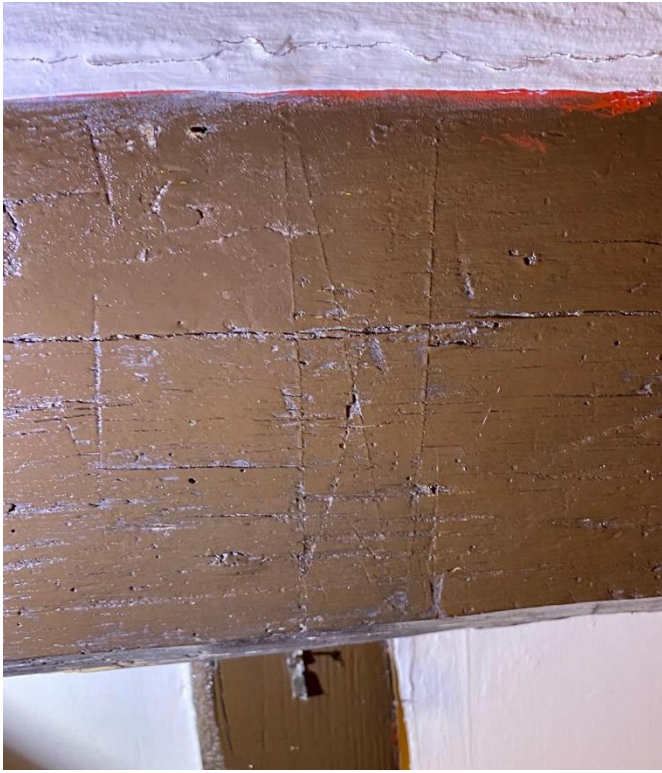
Lobby door frame South side = deeply incised compass drawn circle (3cm diameter) and other marks which may be carpenter's marks.

Downstairs, south room = one burn mark and three compressed X marks (two on the original 16th century dearn door and one on the north wall).

Discussion: Downstairs compass-drawn circle next to the inserted 17th lobby door so of that date or later. Presumably the compressed X on the blocked up 16th century door was contemporaneous with the door. The butterfly mark in in a similar upstairs position as seen in 54 Low Street (similar aged house). All but one burn mark were in one upstairs room.

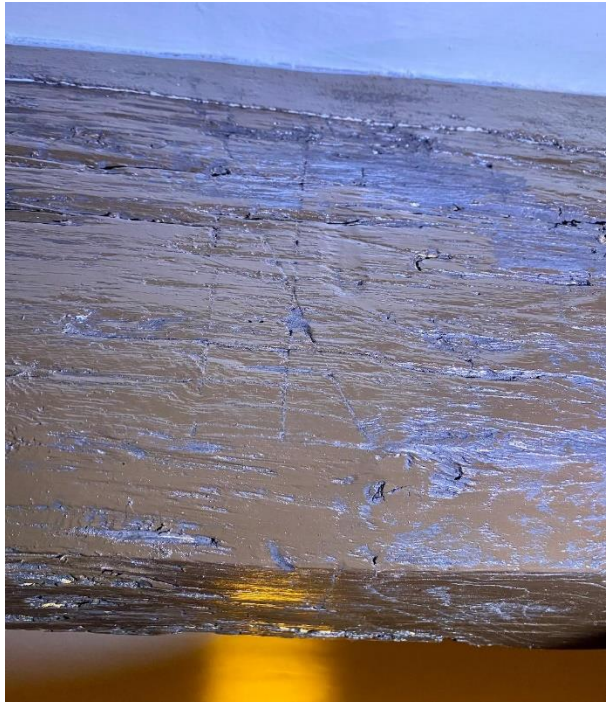
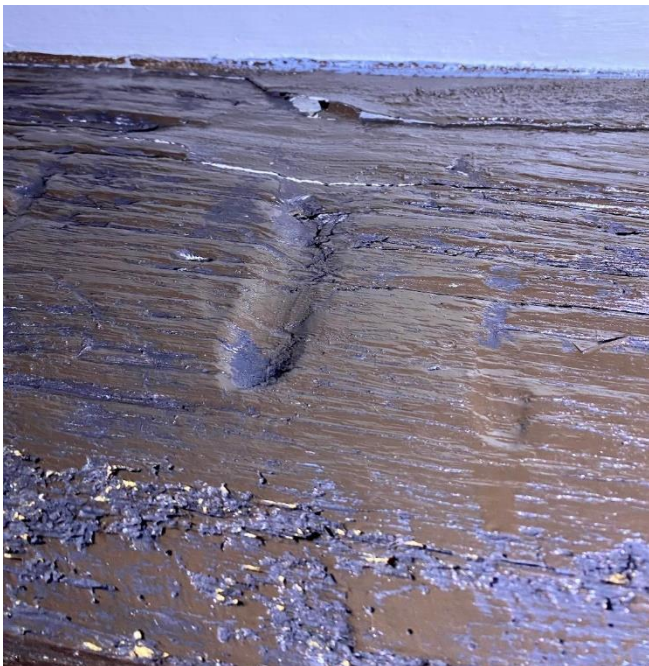
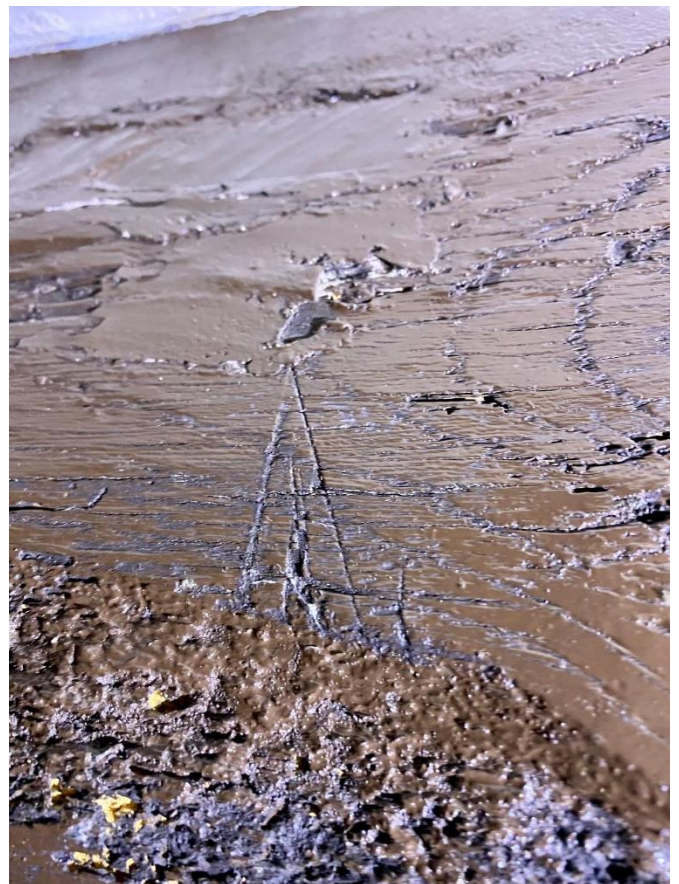
Upstairs = in southern first floor room south beam = butterfly mark and two burn marks (shallow). On the beam facing the inserted chimney = 8 burn marks, possibly one M (incomplete) and lightly scored out. One other sharp "A?" marks could be carpenter's marks
