53 and 54 Low Street (both are part of one house dating c1500-1530. Transitional hall house built around the chimney).

54, Living room. Bressummer, south facing. Sand blasted but heavily covered in markings.

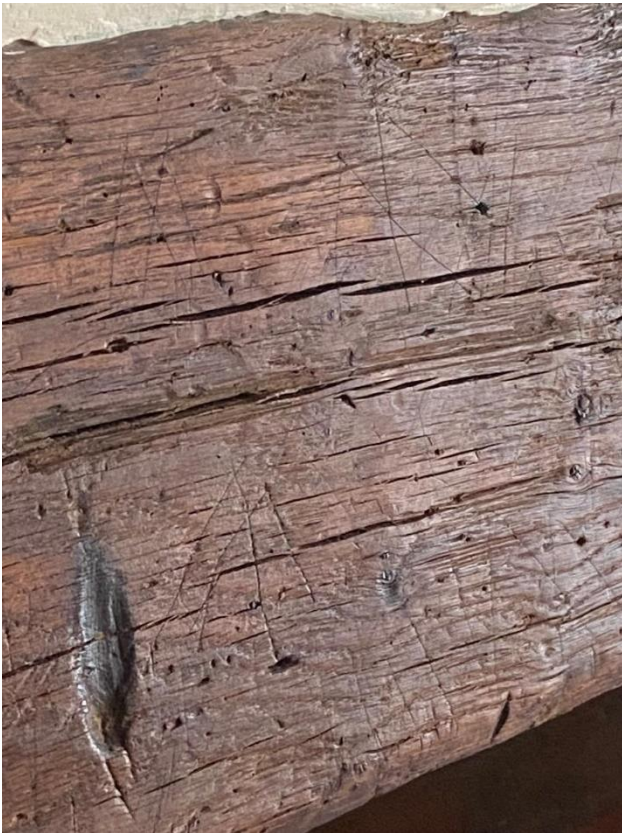
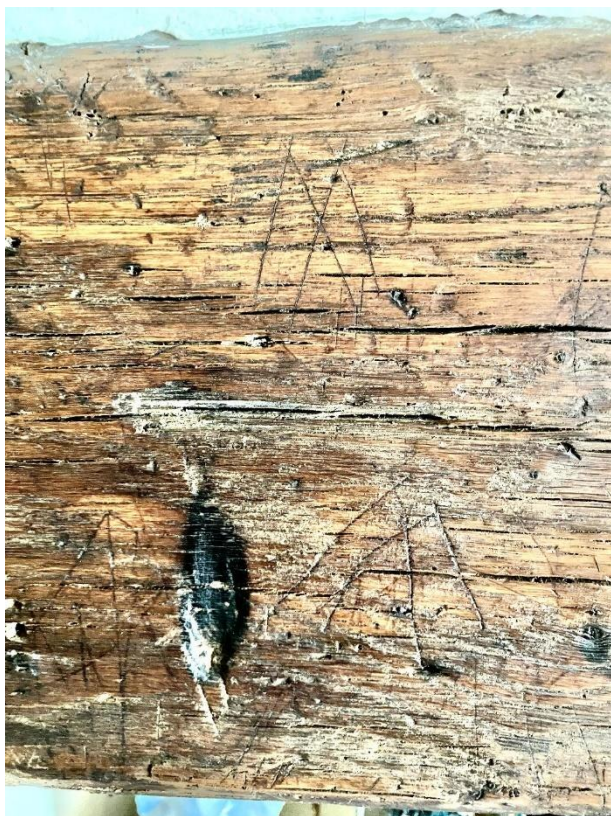
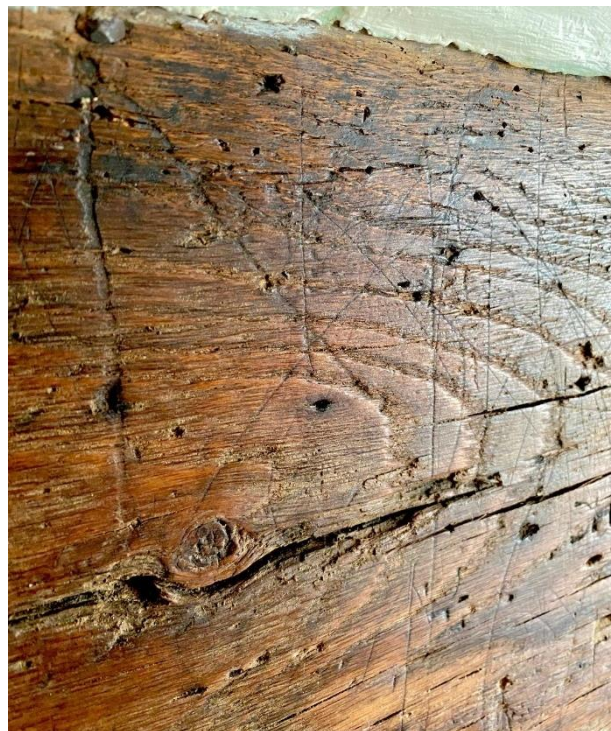
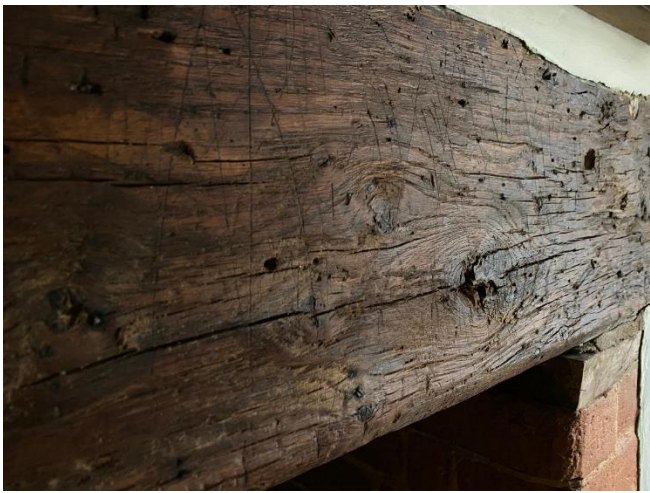
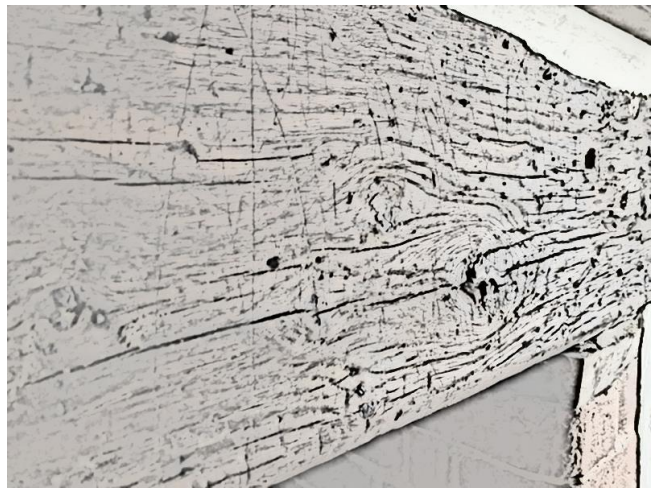
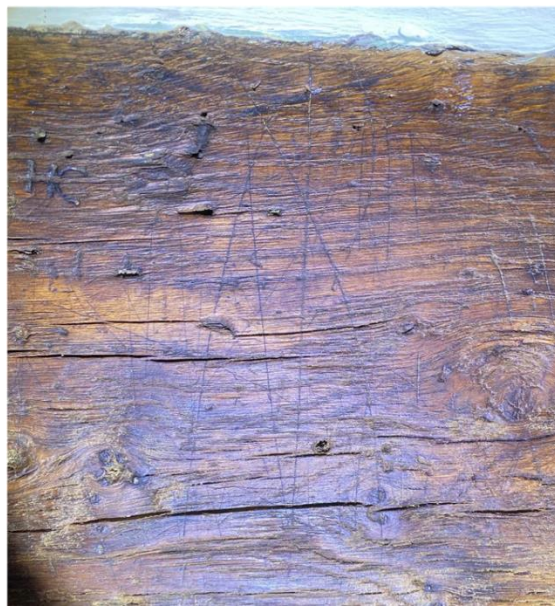
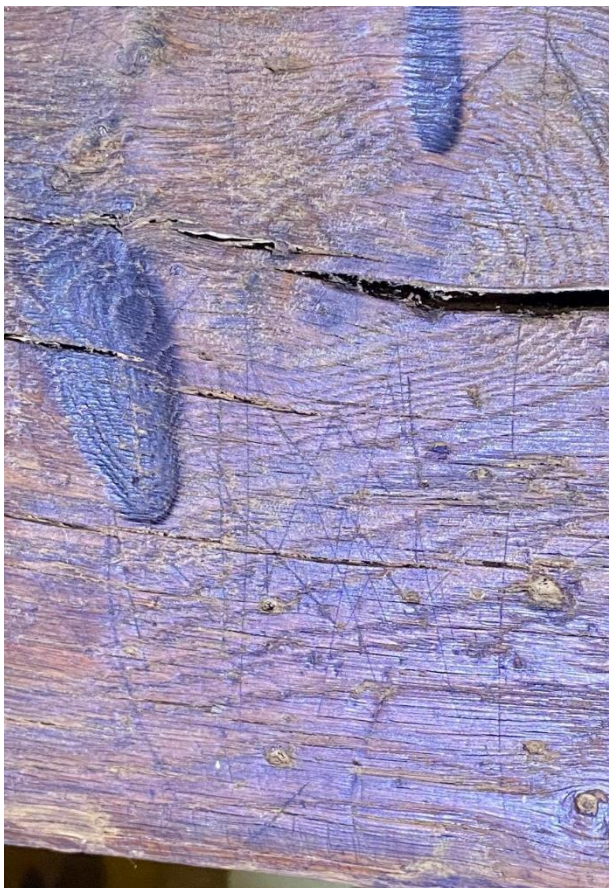
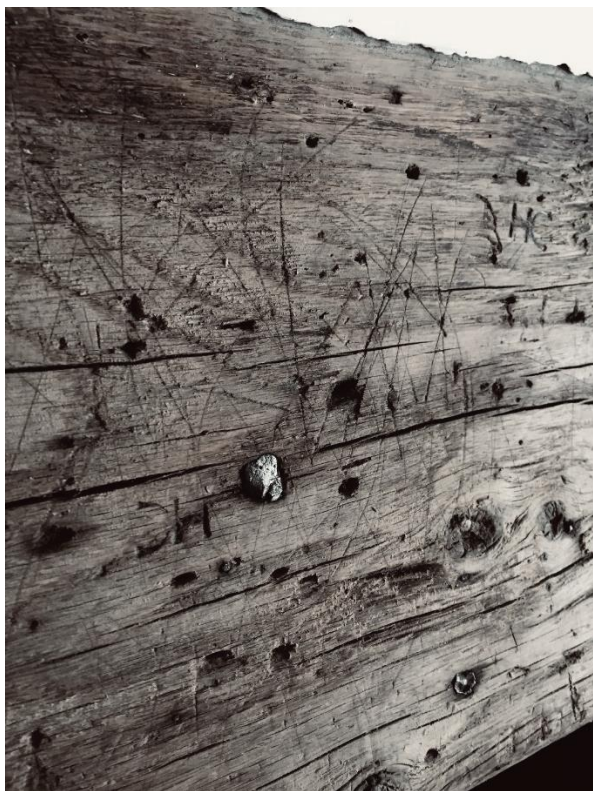
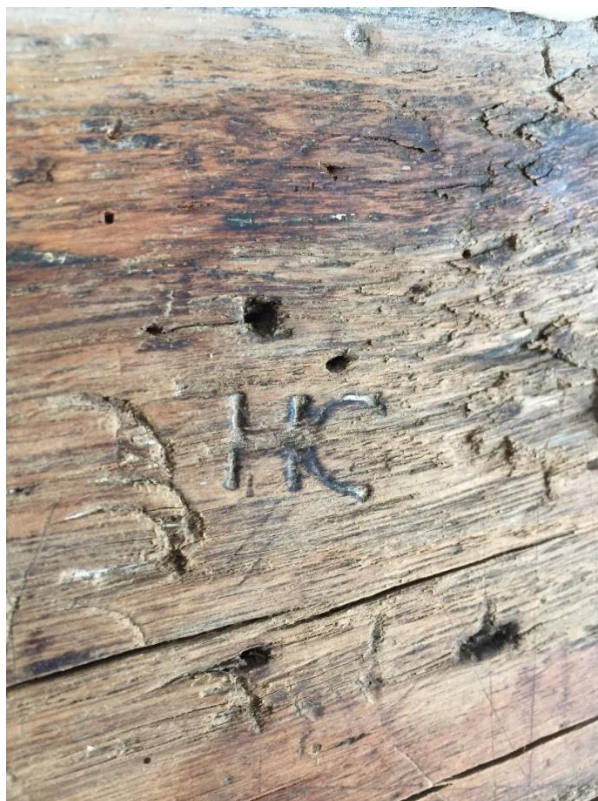
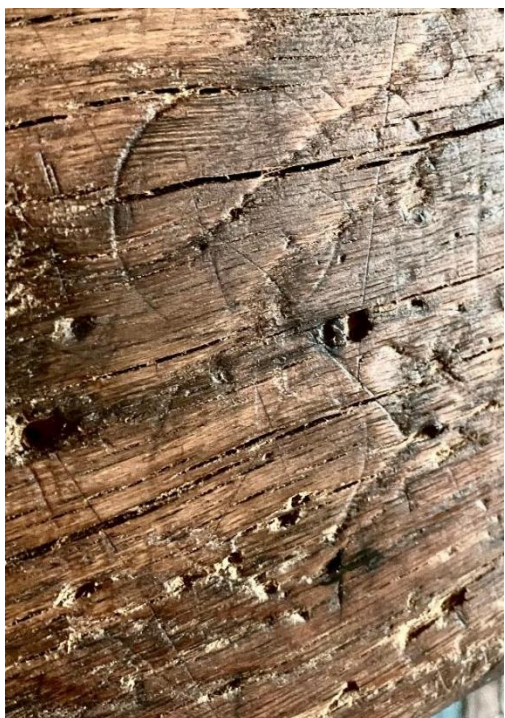
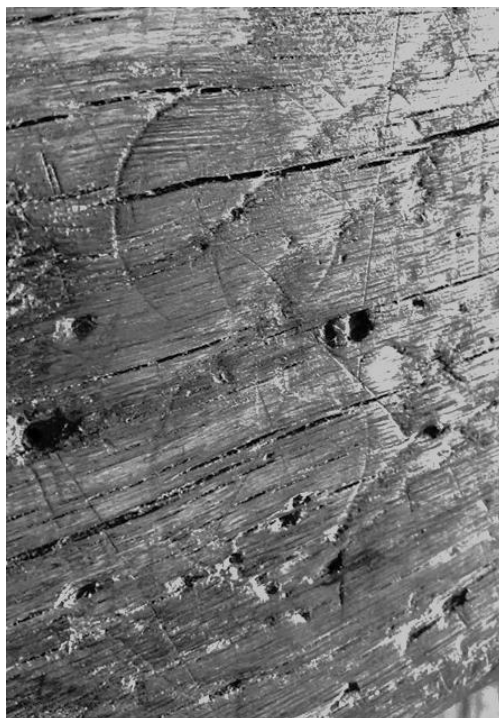
Symbol	Number
M	7
AM	2
Daisy Wheel	0
Consecration cross	0
Compass drawn circle	4
Butterfly	1
Arrow	1
Mesh	0
Cross	0
Burn	5
Chi rho	0
Stamp	3 HC, one sideways one back to front
Comment	Daisy wheel with three strikes through it on door frame to the left

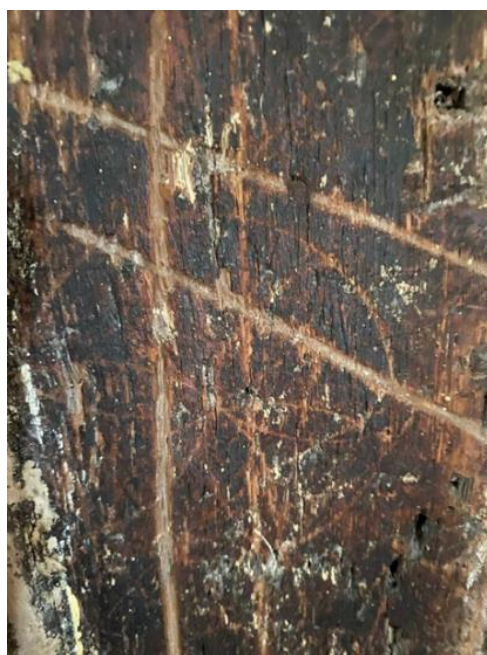
Daisy wheel struck through with 3 lines

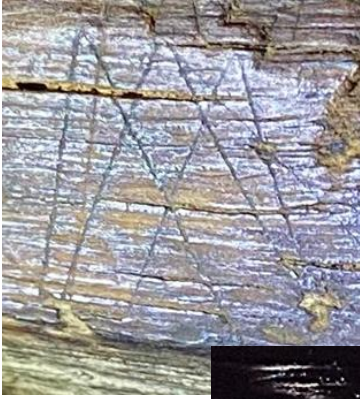
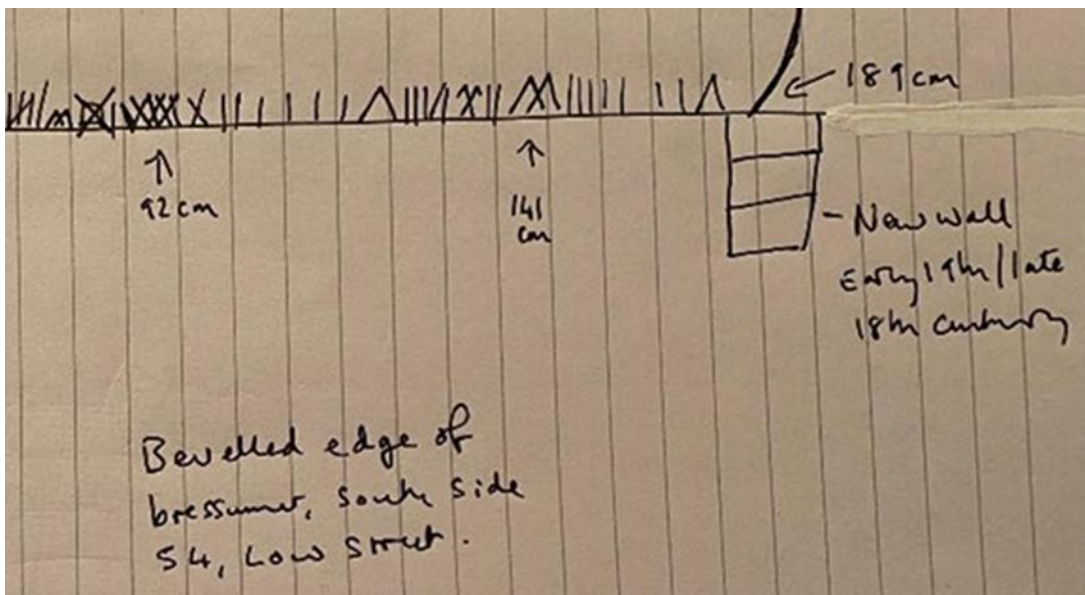
Chamfered edge of bressummer

Supplimentary investigation – on checking photos with high magnification I noticed small symbols inscribed on the chamfered part of the bressummer not bigger than 1 cm tall. AM and M marks present, zig-zag (lightening) and cross-star and saltire cross amongst others. They appear to be contemporary with the insertion of the bressummer 1500-1530.

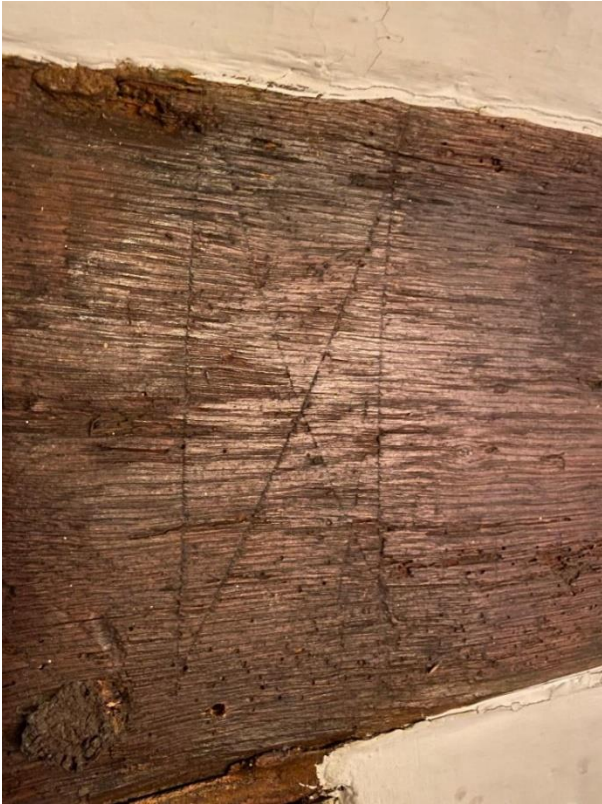
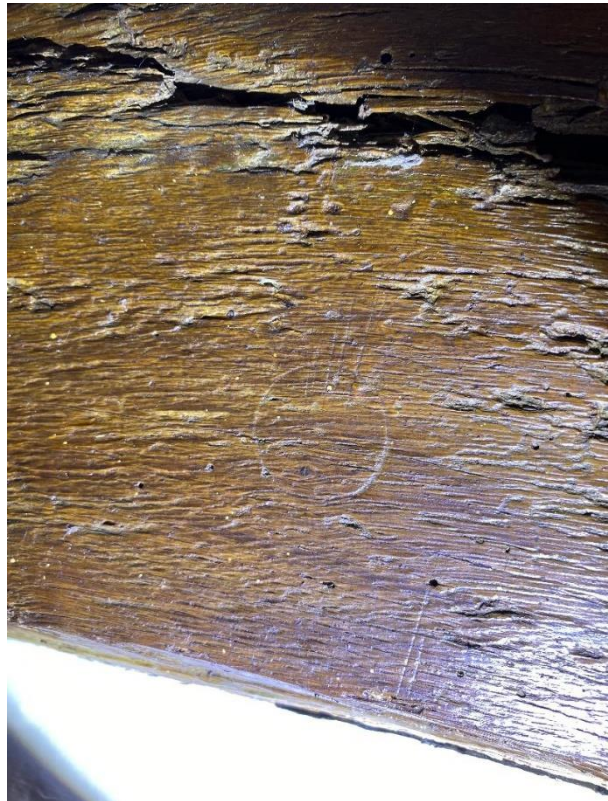
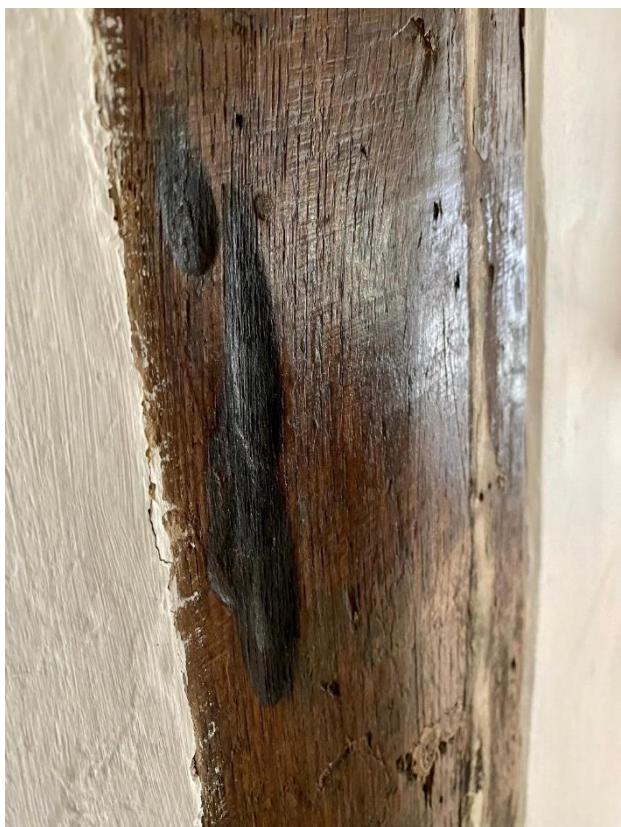
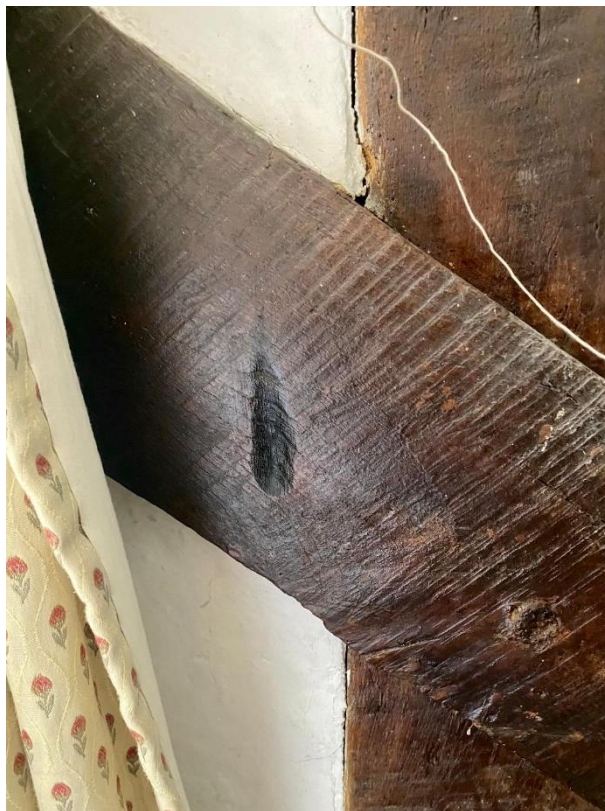
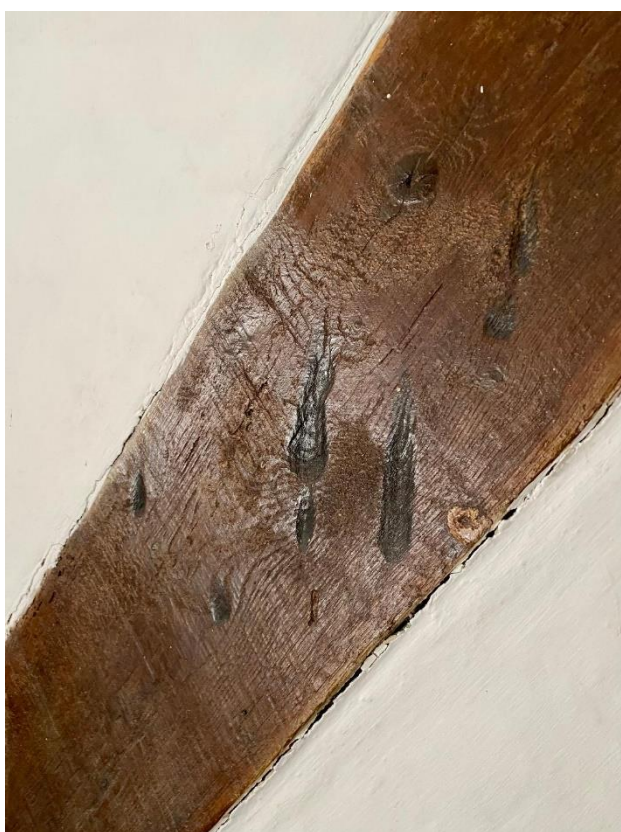
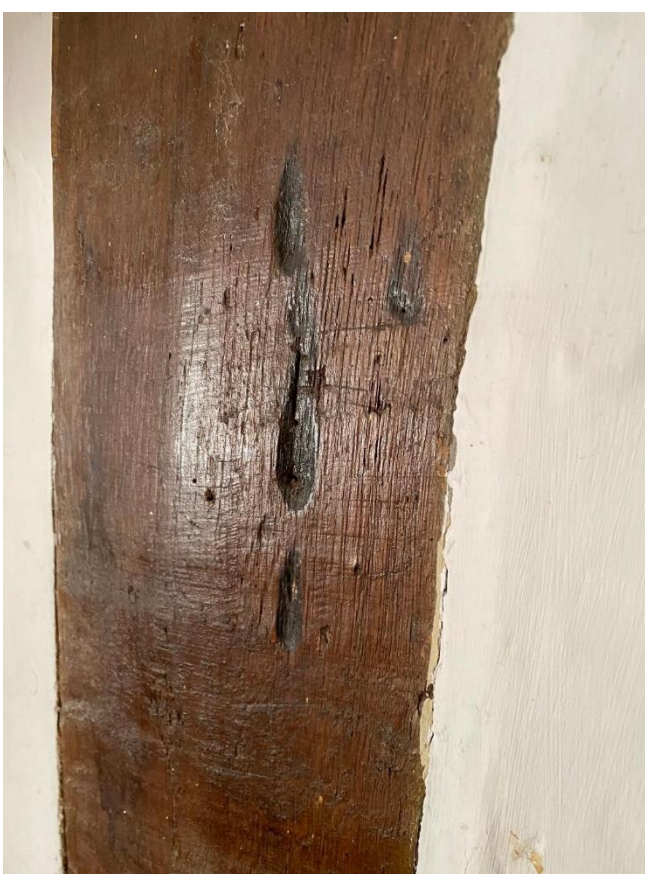
54. First floor, central room.

Two butterfly marks on ceiling beams (east and west above windows), one compass drawn circle on south ceiling beam, mesh design below light switch on south wall. Many burn marks on South, East and west wall.

Symbol	Number
M	
AM	
Daisy Wheel	
Consecration cross	
Compass drawn circle	1
Butterfly	2
Arrow	
Mesh	1
Cross	
Burn	19
X	
Chi rho	
Stamp	
Comment

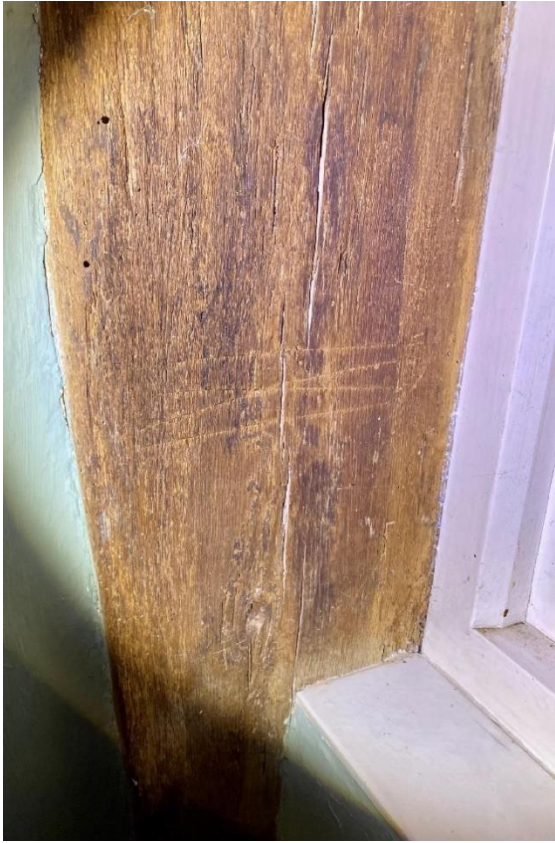
1st floor bedroom south of chimney stack = 9 burn marks., mainly around fire place.
