Abbeyview 1.2.22

HOXNE CROSS STREET TM 17 NE 8/68 Abbey View GV II House. Late C15 with mid C17 rear wing forming L-shape plan. Alterations of c.1600, c.1700 and c.1924. Timber framed, the facade and gable ends encased in red brick c.1924 with white brick dressings at the angles. Plastered to rear. Roof has double Roman tiles to front and pantiles to rear. 2 storeys and attic. A former open hall house of 3-cell form. 3 windows, 3-light casements under segmental lintols. 2 C17 mullioned windows have been opened out to the rear. Lobby entrance with mid C20 6-panel door and open lean-to porch. Internal stack. 2 further stacks to rear wing, one at the gable end. An intact frame in 4 bays, with almost straight arched braces. Evidence for original diamond-mullioned windows. Cambered tie beam over former open hall has evidence for crown-post. The parlour, entered by an original 4-centre arched doorway, has substantial plain joists, perhaps a replacement ceiling of C16 date. In c.1600 the hall was floored over with an axial bridging beam and chamfered joists, a stack being inserted into the upper bay at the same time. Intact hall fireplace with evidence for lining of the mortar joists. In

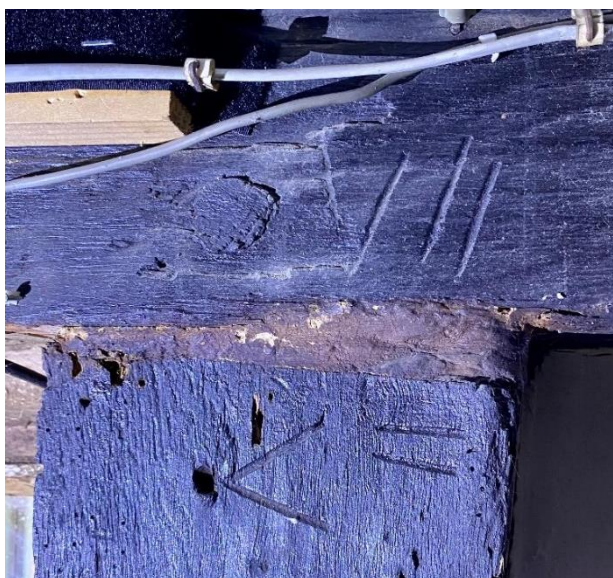
Downstairs NE room

Many beams have roman numerals made by the carpenters who constructed the house. This is a feature of many parts of the original 15th century house. Apart from this, no apparent marks. Bressummer present but had been sanded.

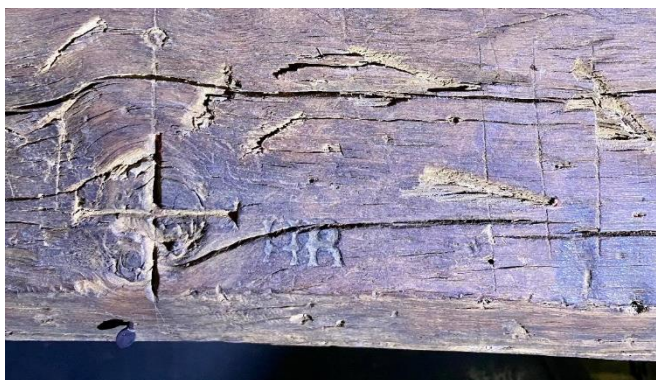
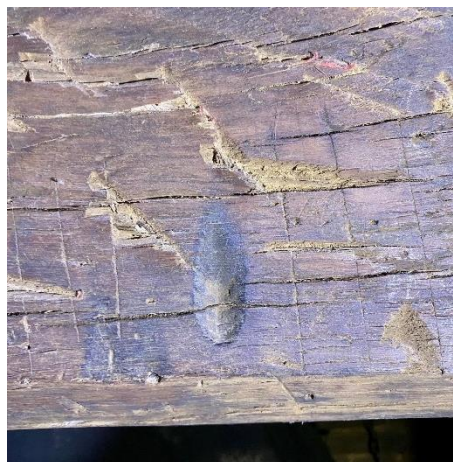
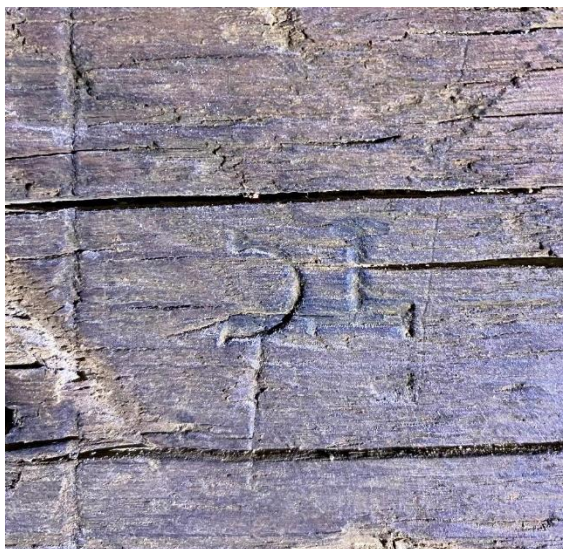
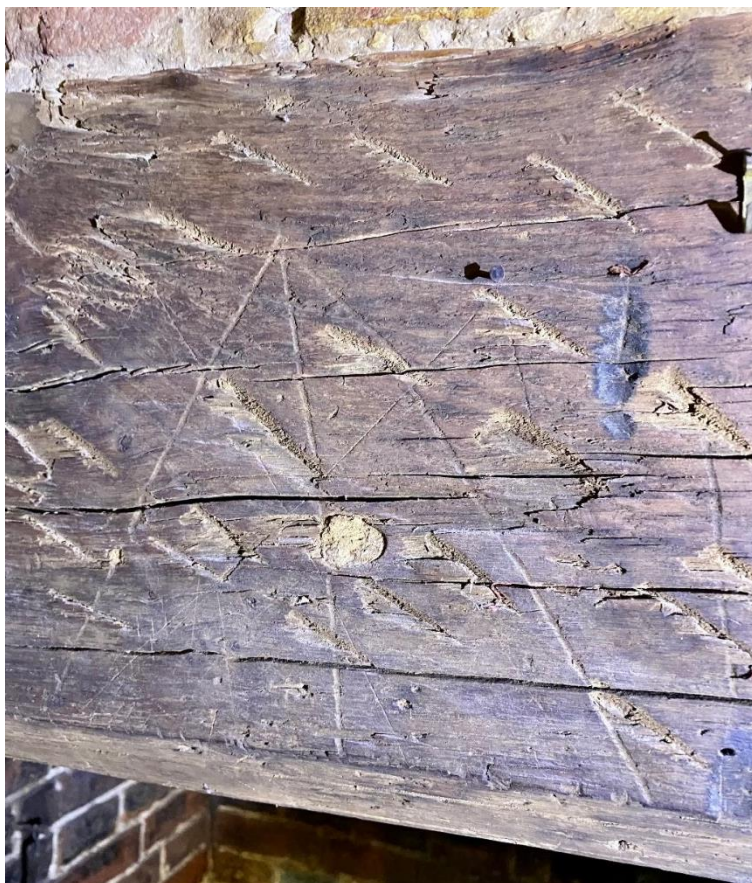
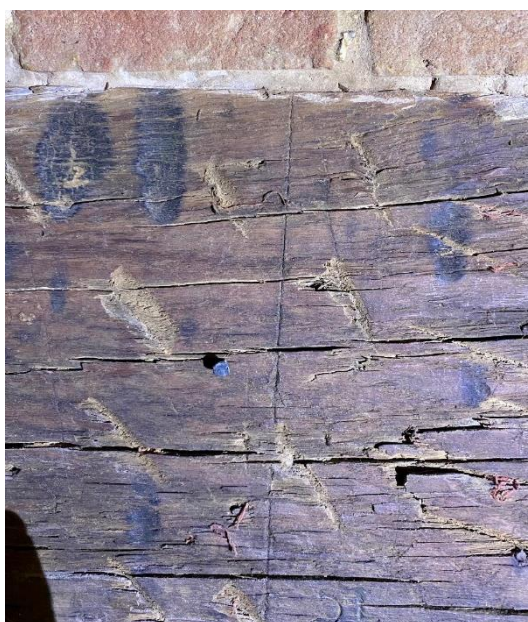
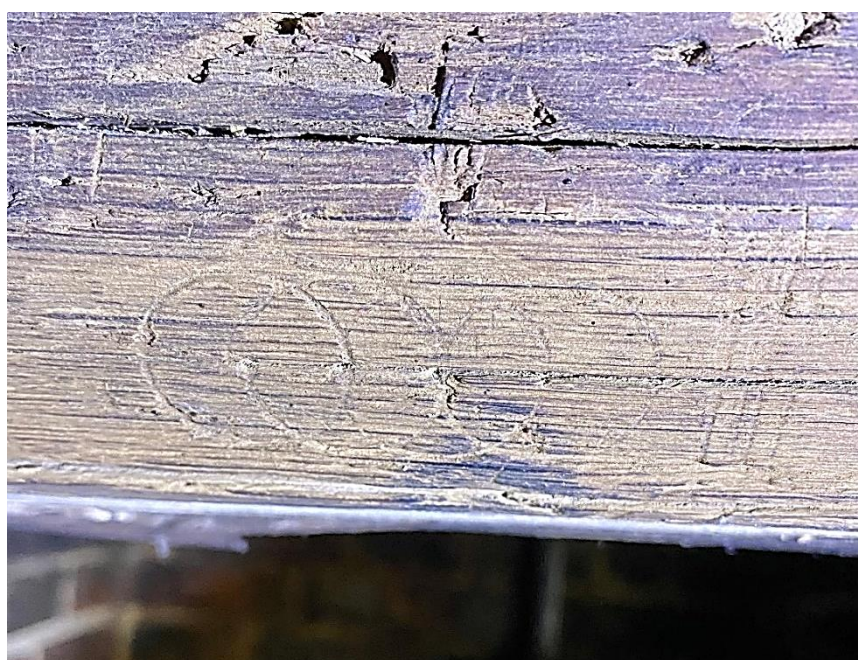
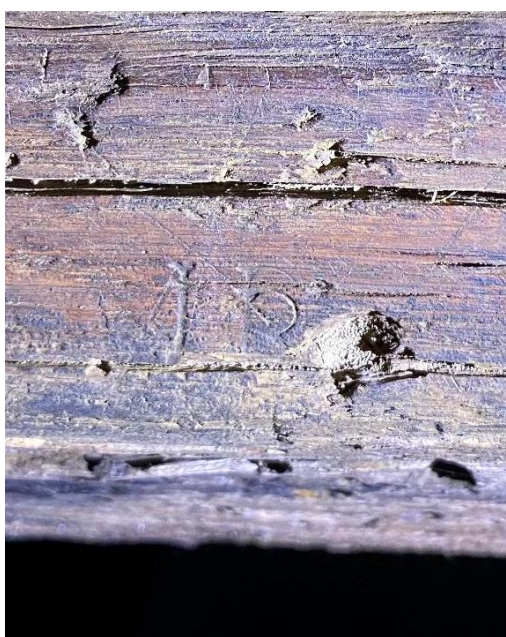
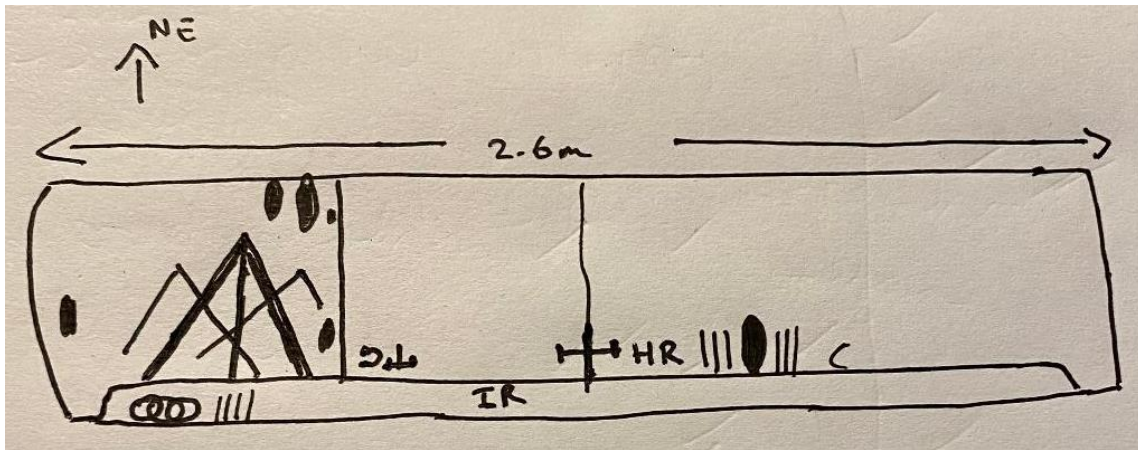
SW Room

Bressummer contains a few marks – stamped initials – HR, TC (inverted) and IP or IR. A large M with fine lines crossed through with a later and deeper A to make a crude AM – Ave Maria. Greek cross, cuts and 11-12 burn marks. On bevelled edge are 4 overlapping circles 4.5cm in length.

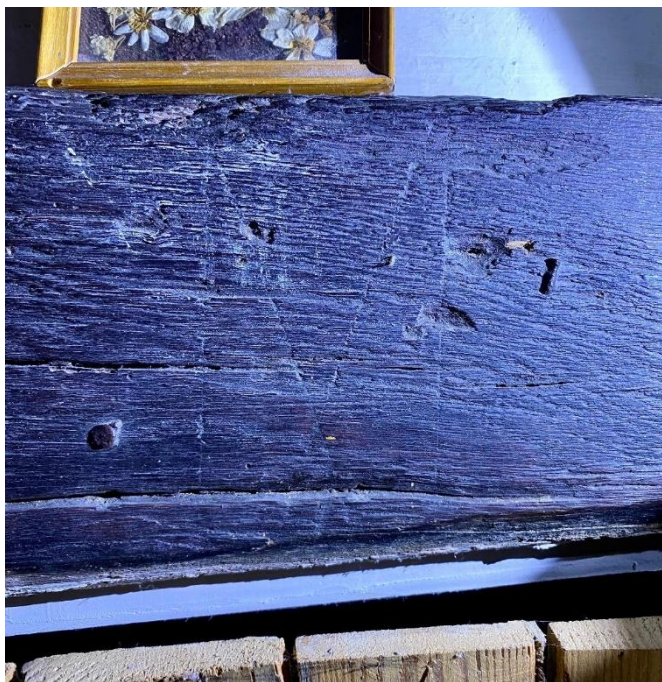
Upstairs, passage way - Butterfly mark possibly above a former window.

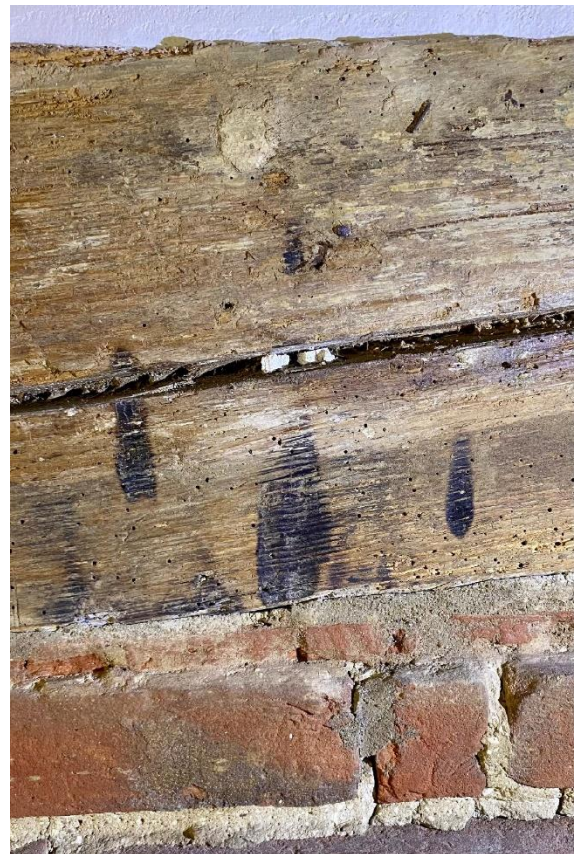
SW room – 1 burn, Central room – 1 burn, NE room 5 burns over fireplace and one on east wall. Faint butterfly mark on SW wall above a filled in window.
