Farm buildings, Mendham (Bert's Barn) IP20 OPE 20.3.22

The barn and stables are late 19th century in design and date. It was present on the 1883 map of the area. The block adjoining it to the South West is later, possibly early 20th century. It belonged to your paternal grandfather (Alfred) Bertie Godbold, who was then farming at Highfields further along Foxes Lane towards Metfield. He bought 68 acres from Chestnut Lodge in the mid 1930s. This land included the building you have named Bert's Barn. Bert's only child was your father (Edward) John Godbold, 1926-2018. His initials are seen in photo 4, dated 1945. The other buildings must be late 50s or early 60s. Your father built his house in 1960. The map below records the marks and objects we observed and the location of photos included.

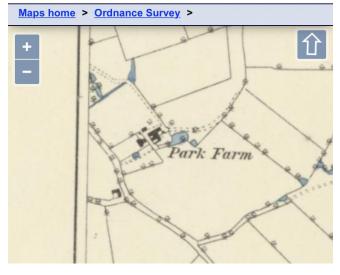
Suffolk Sheet XVII.SW

Surveyed: 1883, Published: 1884 Size: map 31 x 46 cm (ca. 12 x 18 inches), on sheet ca. 43 x 58 cm (ca. 17 x 23 inches)

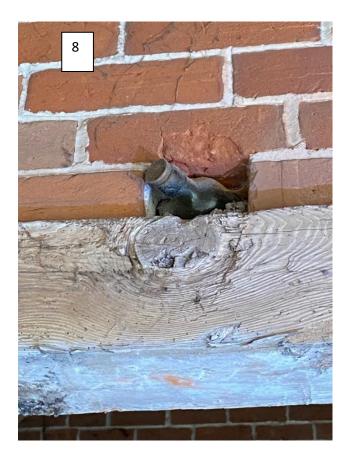
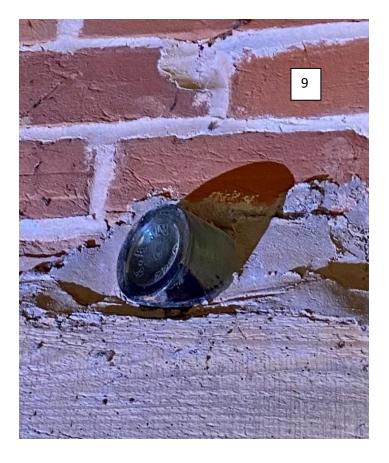
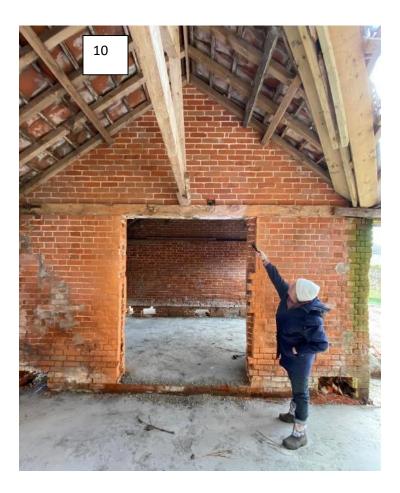
1. On the NW wall (photos 8-10) about 2-2.5m high is a bottle set into and through the wall. It looks like a soft drink bottle/beer with a stopper in it of the style of the late 19th/early 20th century. It is tilted slightly to allow the dark liquid contained in it (photo 8&9) to drain downwards and

not leak out of the stopper. It has been deliberately placed there to avoid anyone breaking it and has been re-affixed by 20th century cement and not lime mortar as it would have originally been.

in the morning had been hag-ridden during the night" – from Physical evidence for Ritual Acts, Sorcery and Witchcraft in Christian Britain. A feeling for magic. Likewise, Brian Hoggard has written a chapter in the same book on witch bottles which you have in Bert's Barn. I have passed on this report to him as he is interested in our findings. He has also written a fascinating book called "Magical Hose Protection. The Archaeology of counter-witchcraft" and there is a chapter on witch bottles. Your bottle is found in both the stable and the animal stalls the other side and was there to protect the animals from the onslaught of malign forces.

Since this report you have been able to look a little more closely at the immured bottle. It appears that the bottle is a horse tonic, the bottle has not been opened but I assume the brown liquid is just that!

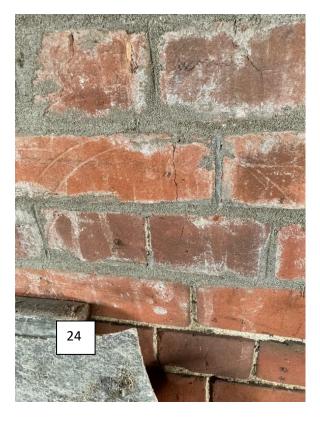
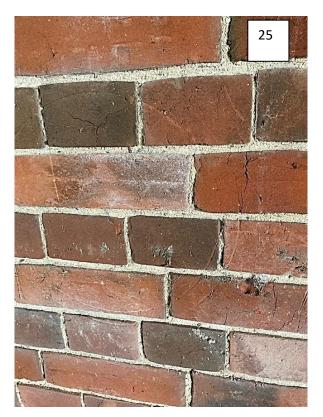
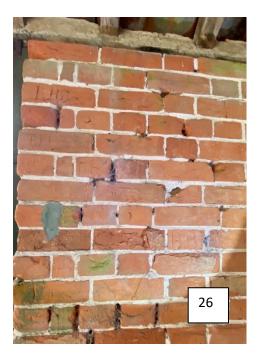
Second building (SW), absent from 1883 map, presumably early 20th century. Photos sent by you.
