C17 timber-frame house. Rendered. Thatched roof with gabled ends. Central brick chimney stack with lozenge-shaped shafts, rendered. One storey and attic. Eaves swept over attic windows. Two windows wide. Modern casements with glazing bars. Late one storey wing on west end with pantile roof.

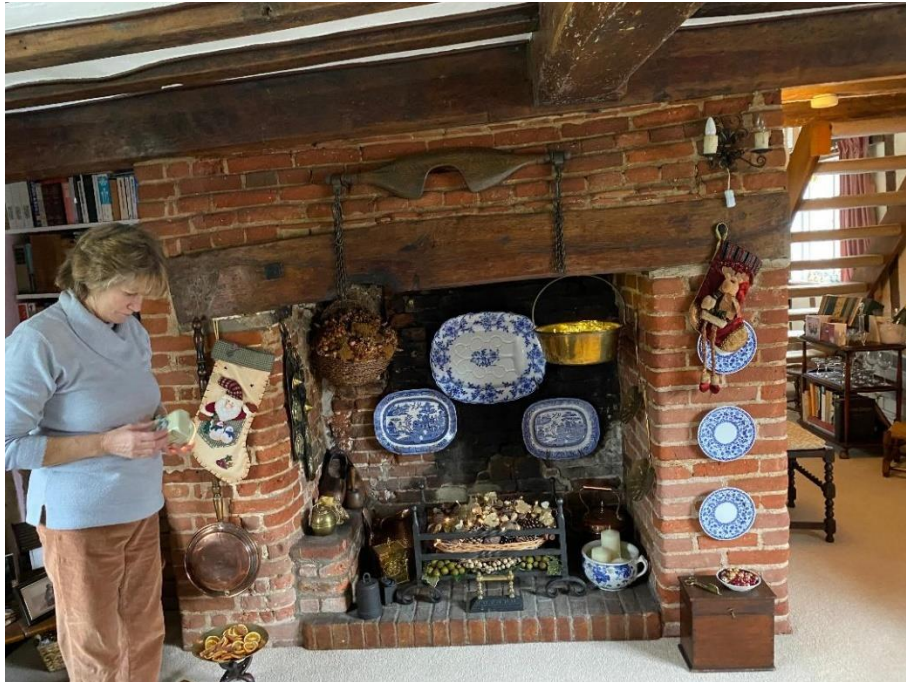
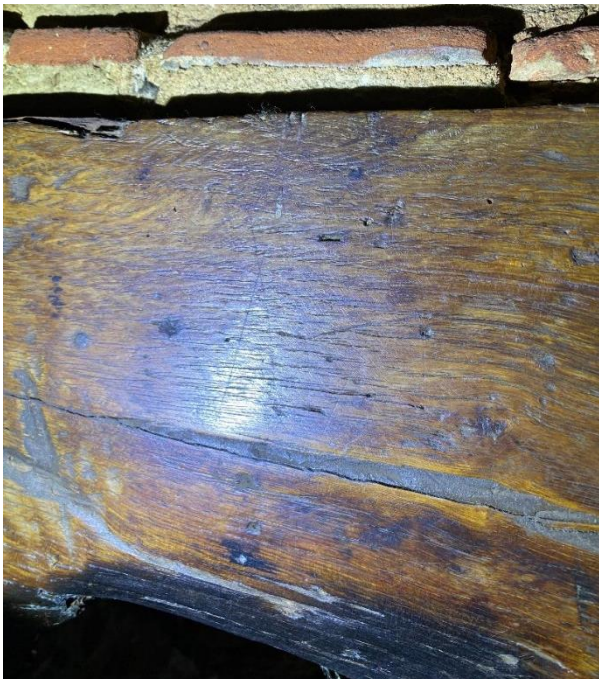
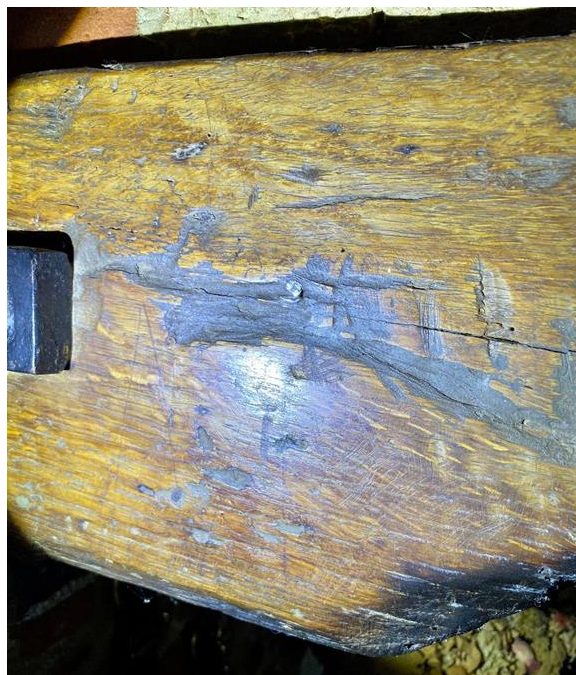
### Ground floor, North room looking south towards chimney stack.

Much of the Bressummer has been heavily abraded by a circular sanding disk. Evidence of two M and one W. Possibly compass drawn circles but more likely to be abrasion marks. Photo included but not drawn in to schematic diagram.

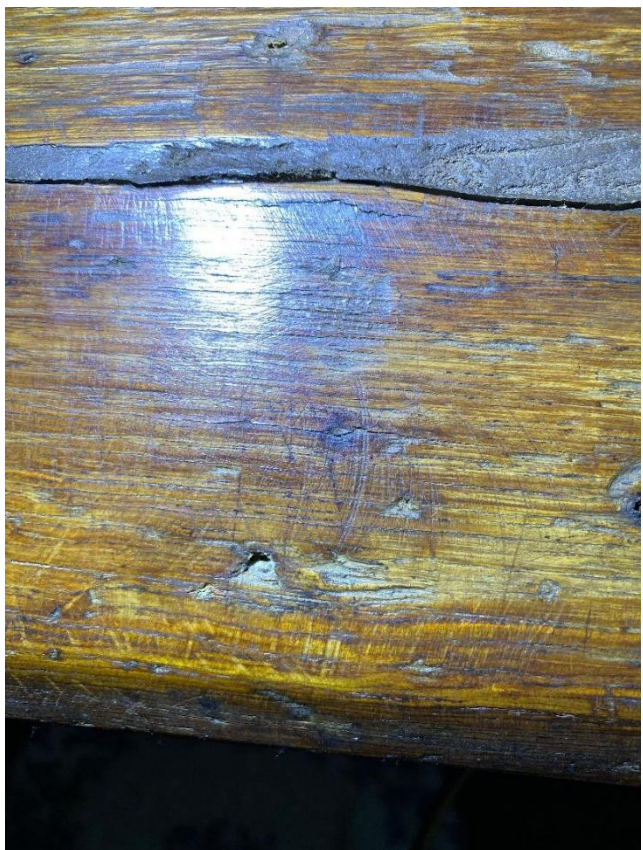
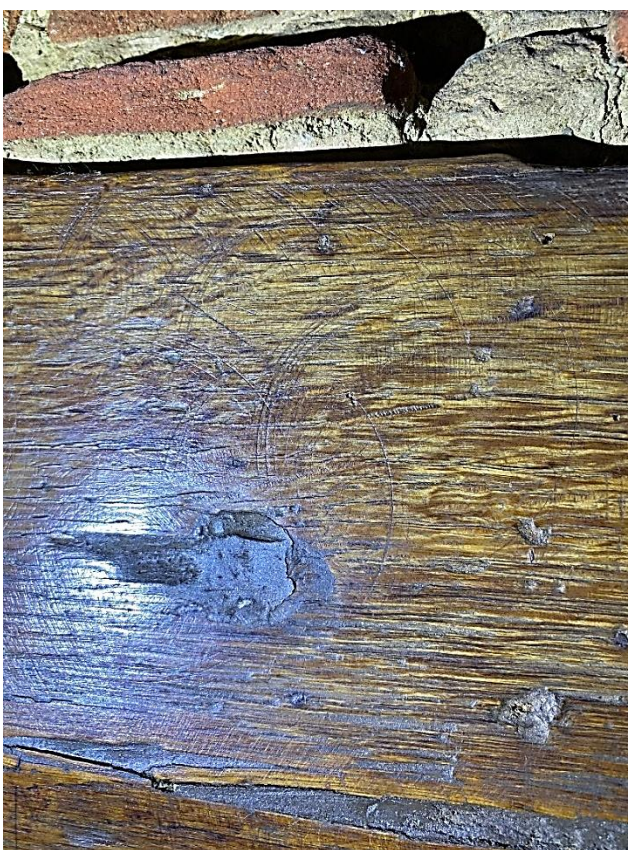
In the NW corner are 4 burn marks on the timber.

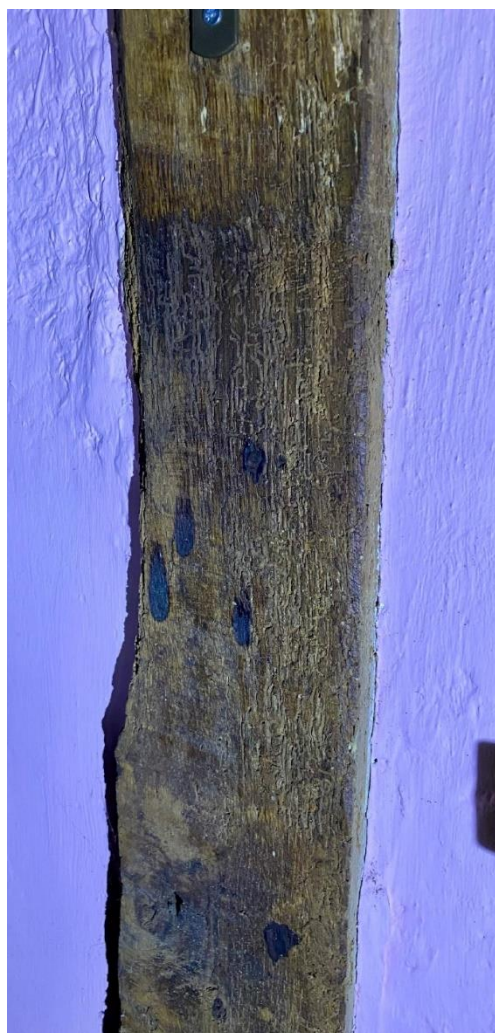
In the central roof beam are a number of indistinguishable marks, possibly part of a circle and slash marks.

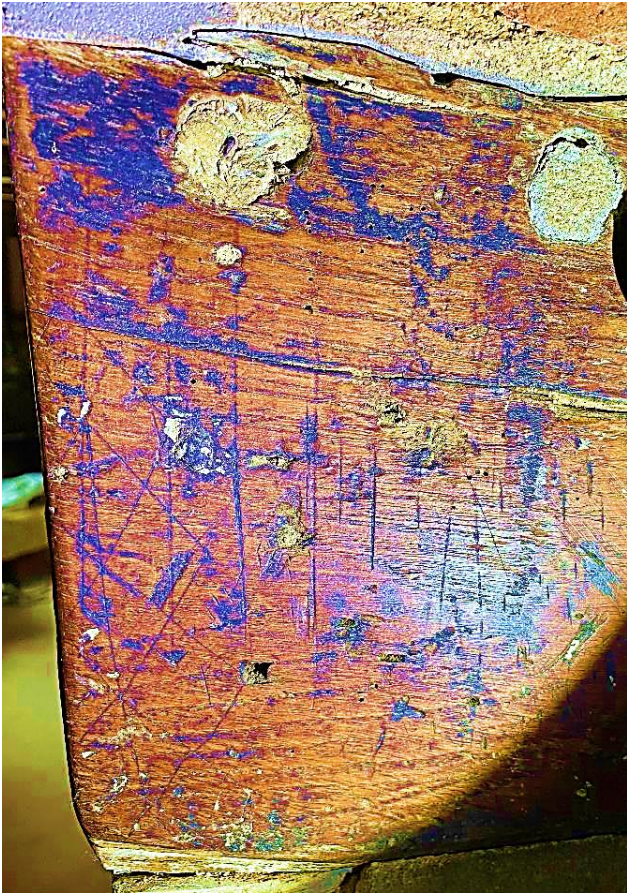
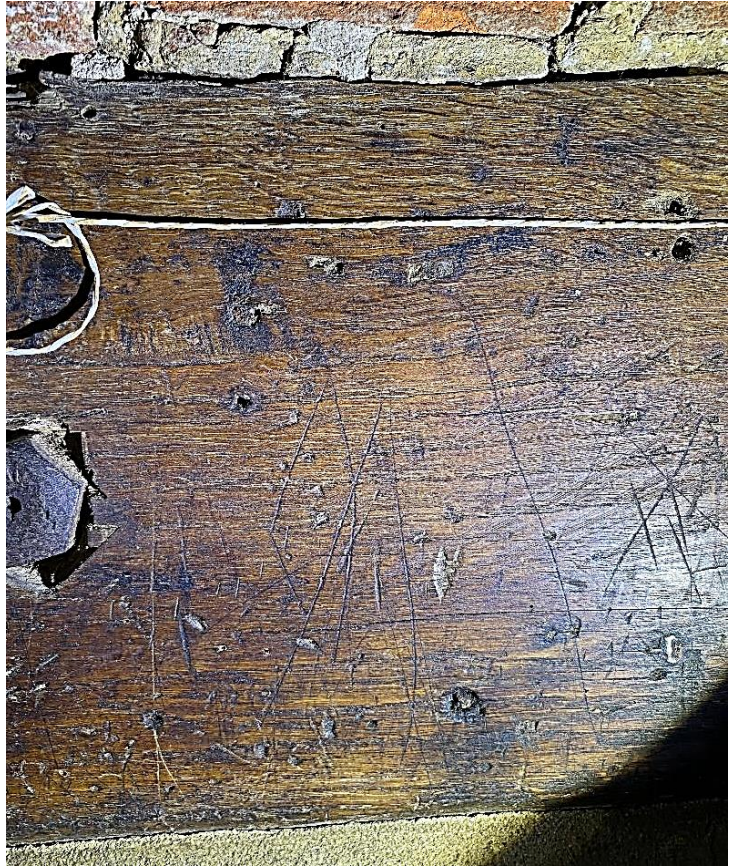
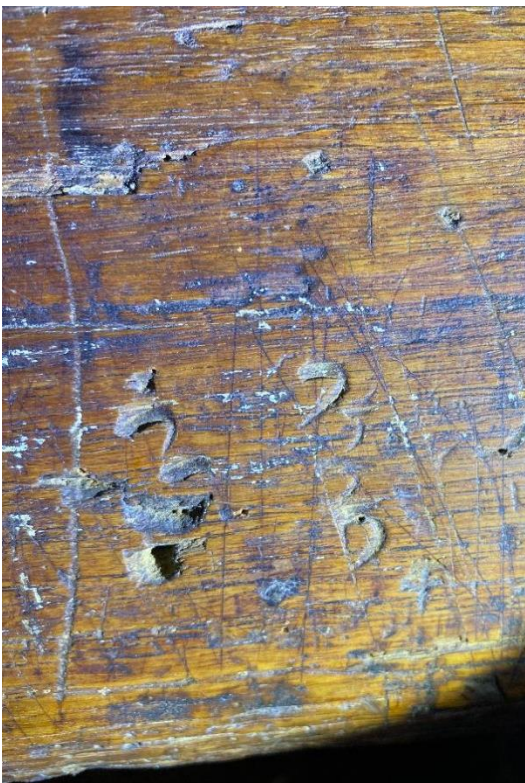
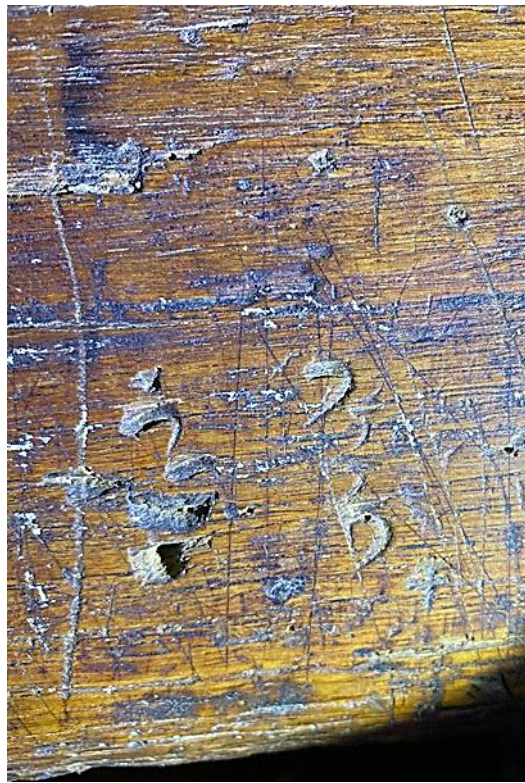
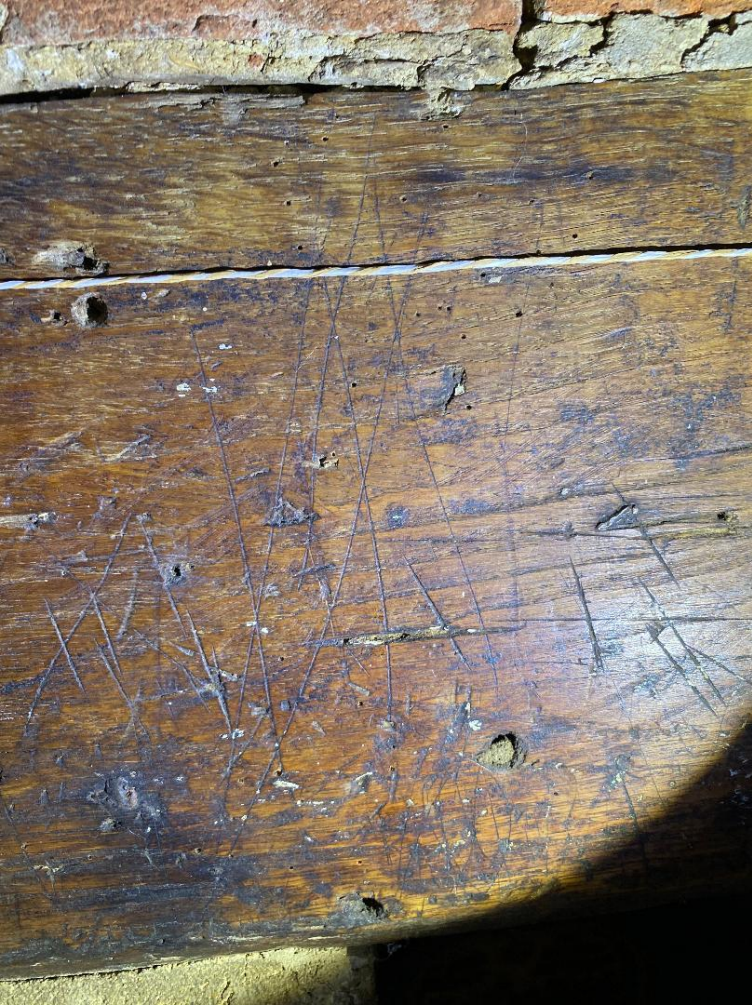
# Southern room, downstairs. North-facing Bressummer.

Lots of marks, beam not so heavily sanded reveals several layers of marks.

There are many different symbols made at a variety of times. Diamond-shaped mesh of left of bressummer, score marks and X marks and grid. A variety of M or W – possibly 3 phases starting with complex and sharp lines (W,M, A cypher), finely drawn and interconnected M (lightening?) followed by later, fewer, rougher and deeper M. Compass drawn circles (several 1.5-3cm diameter) and two hexafoils. Some deeply incised compass drawn circles cut hexafoils. Two partial circles make an “S” shape on its side. 1 clear burn marks, hacked wood, Almond -shape (one other also found above the fire). 3, 3, 3 stamp mark.

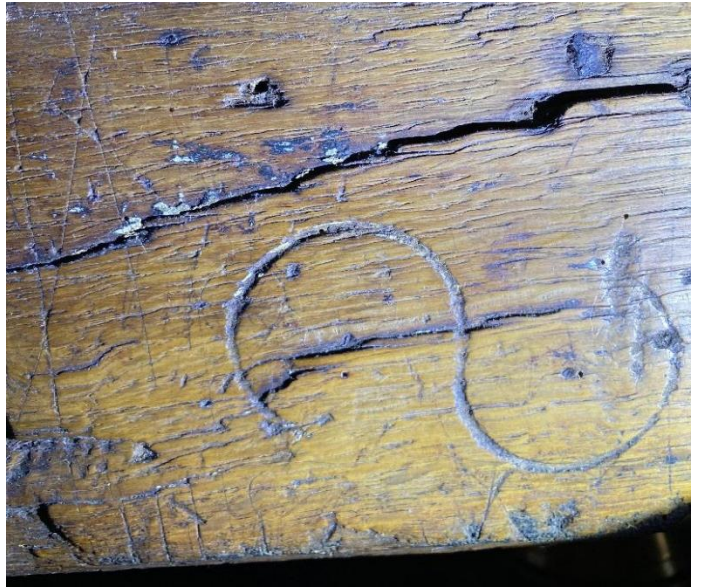
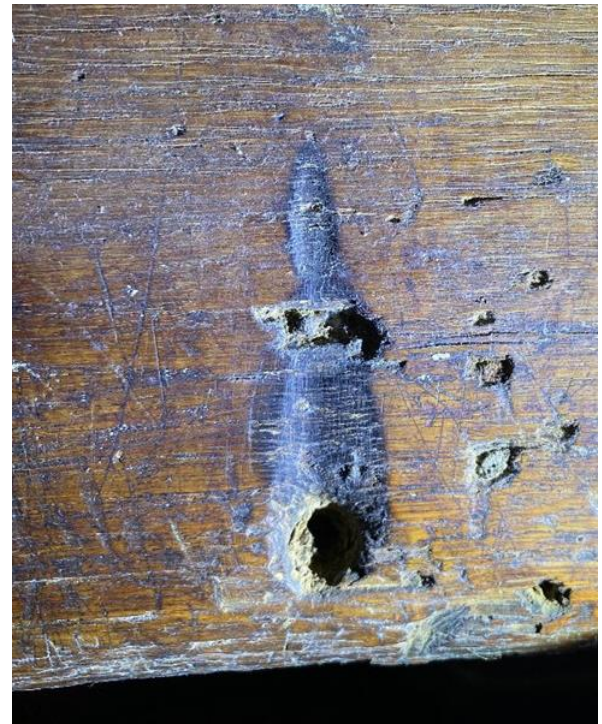
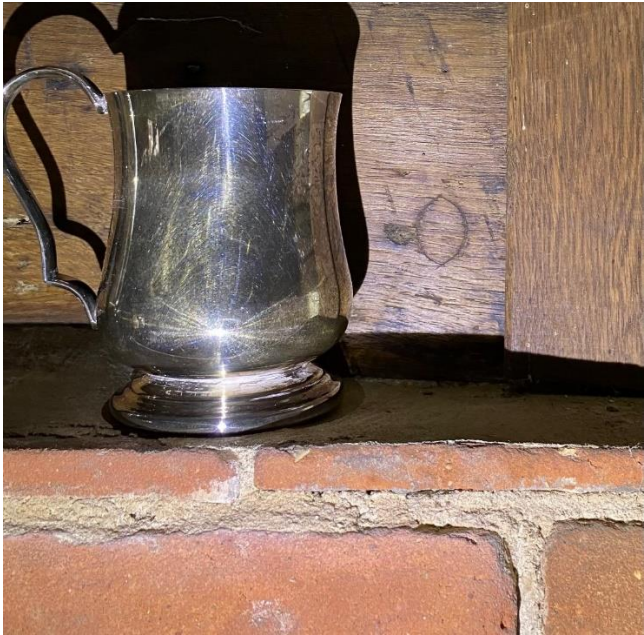
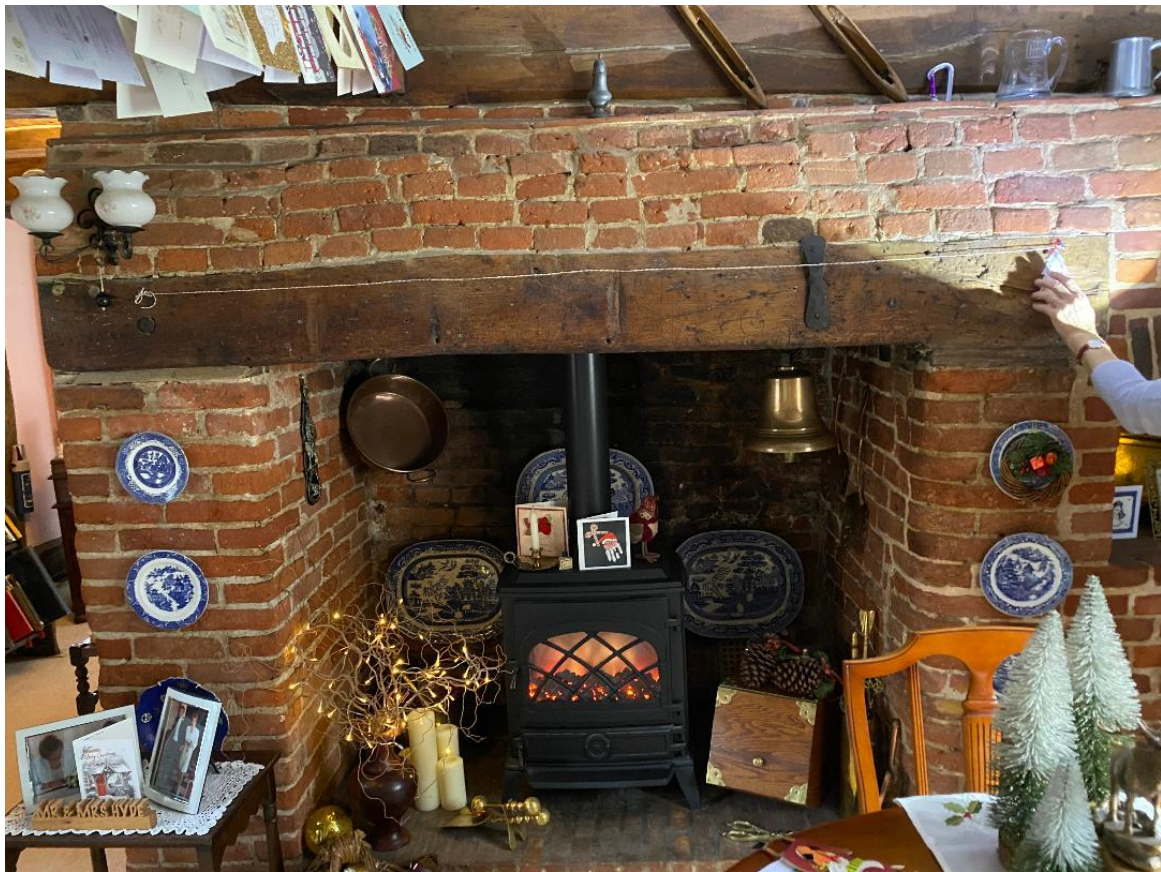
Order of occurrence = Oldest Fine complex M

Hexafoils, burns, M, X

Deep compass drawn circles, deep cruder M and stamps

Arrow (youngest)

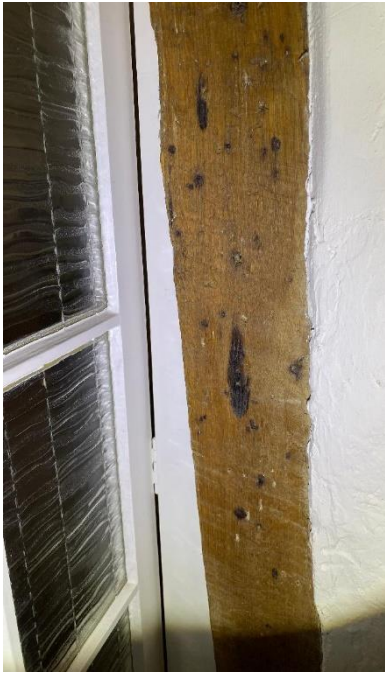
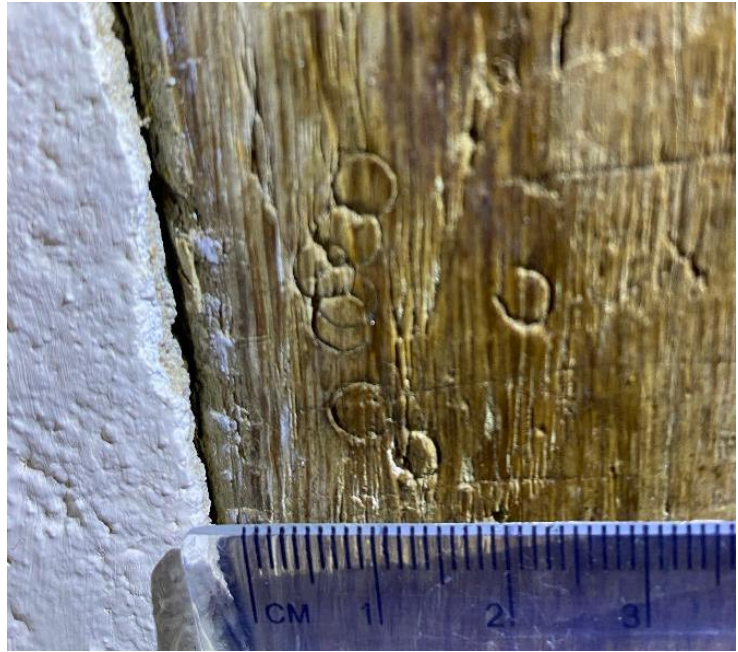
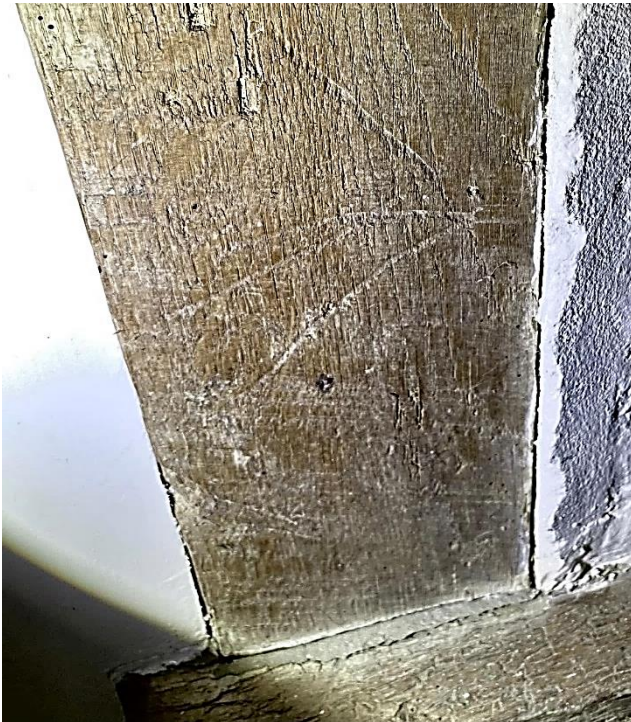
In southern corner of room on west beam of the door = W rotated sideways (deep and crude cut), X mark, burn mark and 8 circular punch mark 2-3 mm diameter, some overlapping.

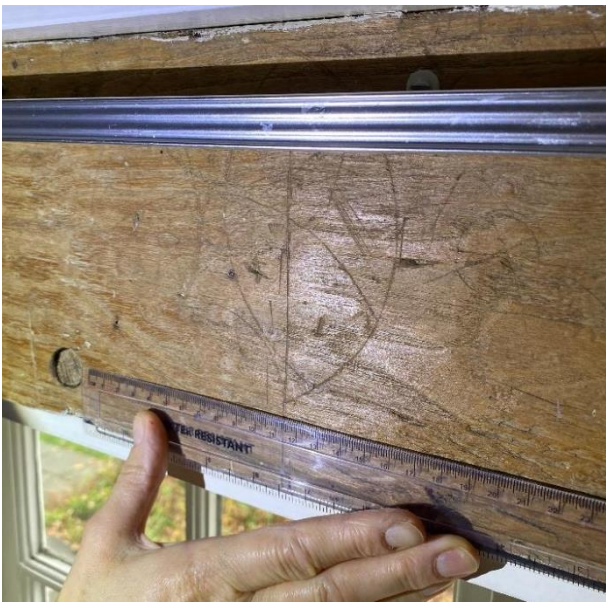
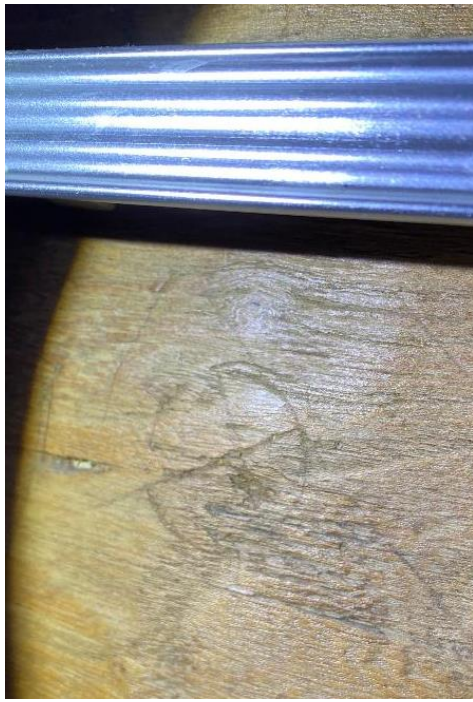
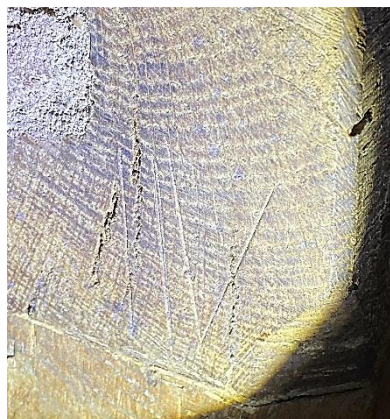
## First floor, north bedroom.

4 circles One large consecration cross (15cm diameter), circle scored out (deeper cut), second more perfect consecration cross 7 cm diameter, larger incomplete circle around it. M mark. All above the window on East side of bedroom. There are a number of carpenters marks.

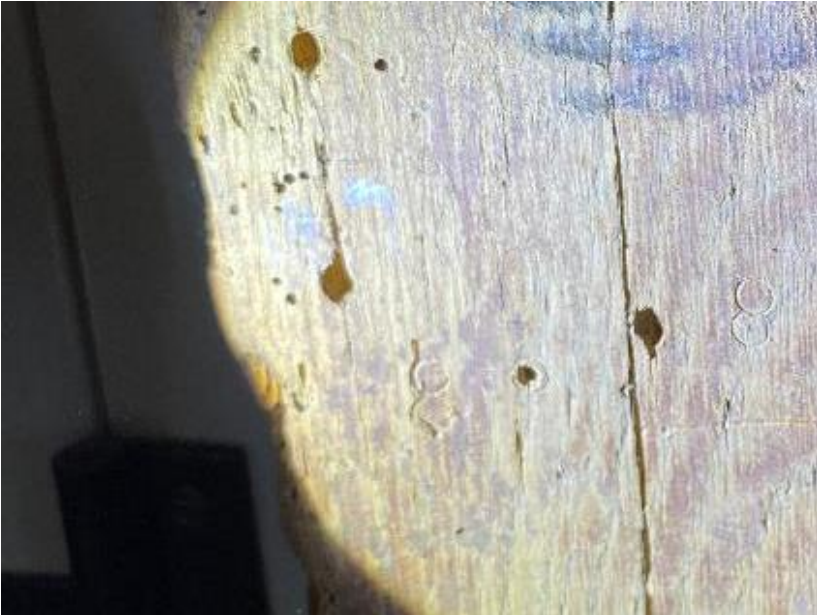
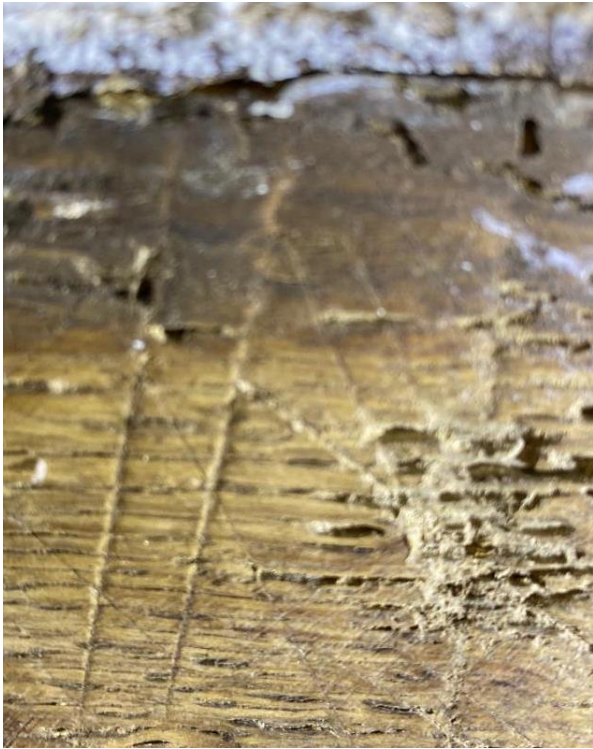
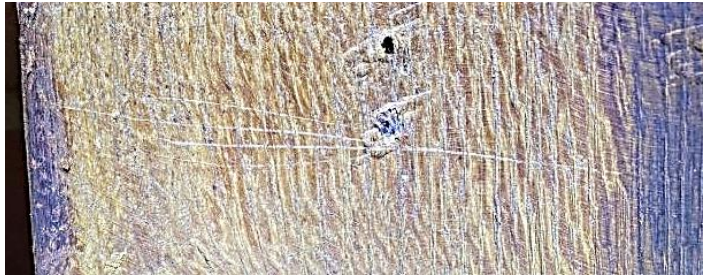
## First floor, south facing bedroom

There are a number of carpenters marks and 2-3 small circular punch marks similar to those downstairs on a vertical door beam on the south of the bedroom. M over window, 1 burn mark. One other split line into 4 lines.
