The Swan, Hoxne

The following is an architectural appraisal of The Swan carried out by the Suffolk Historic Buildings Group in 1996.

Hoxne Swan 18.1.22

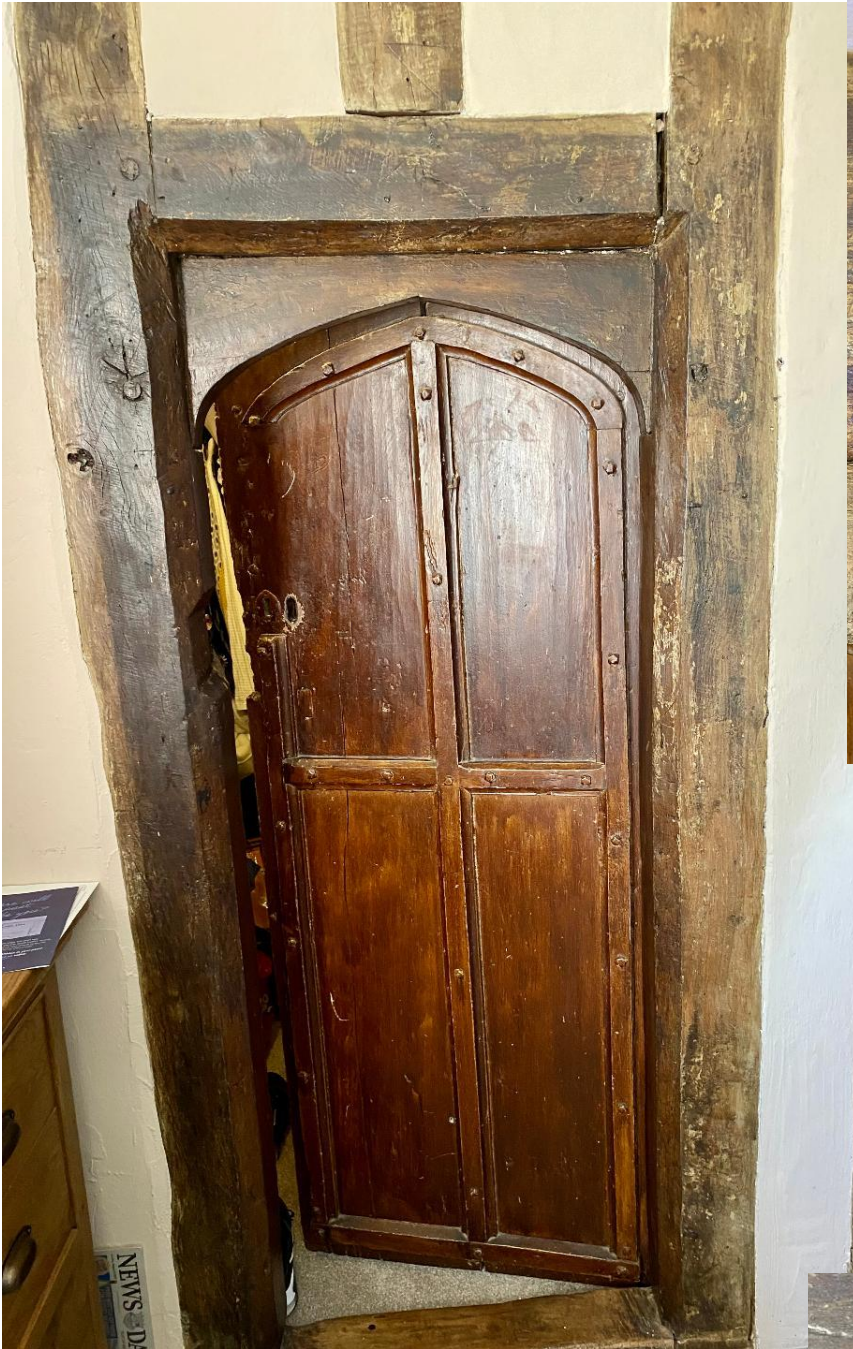
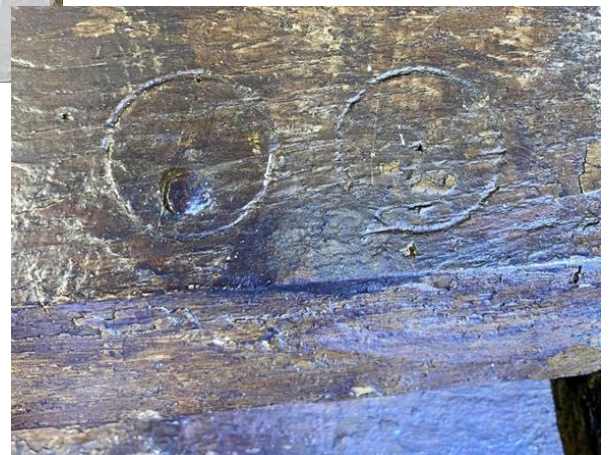
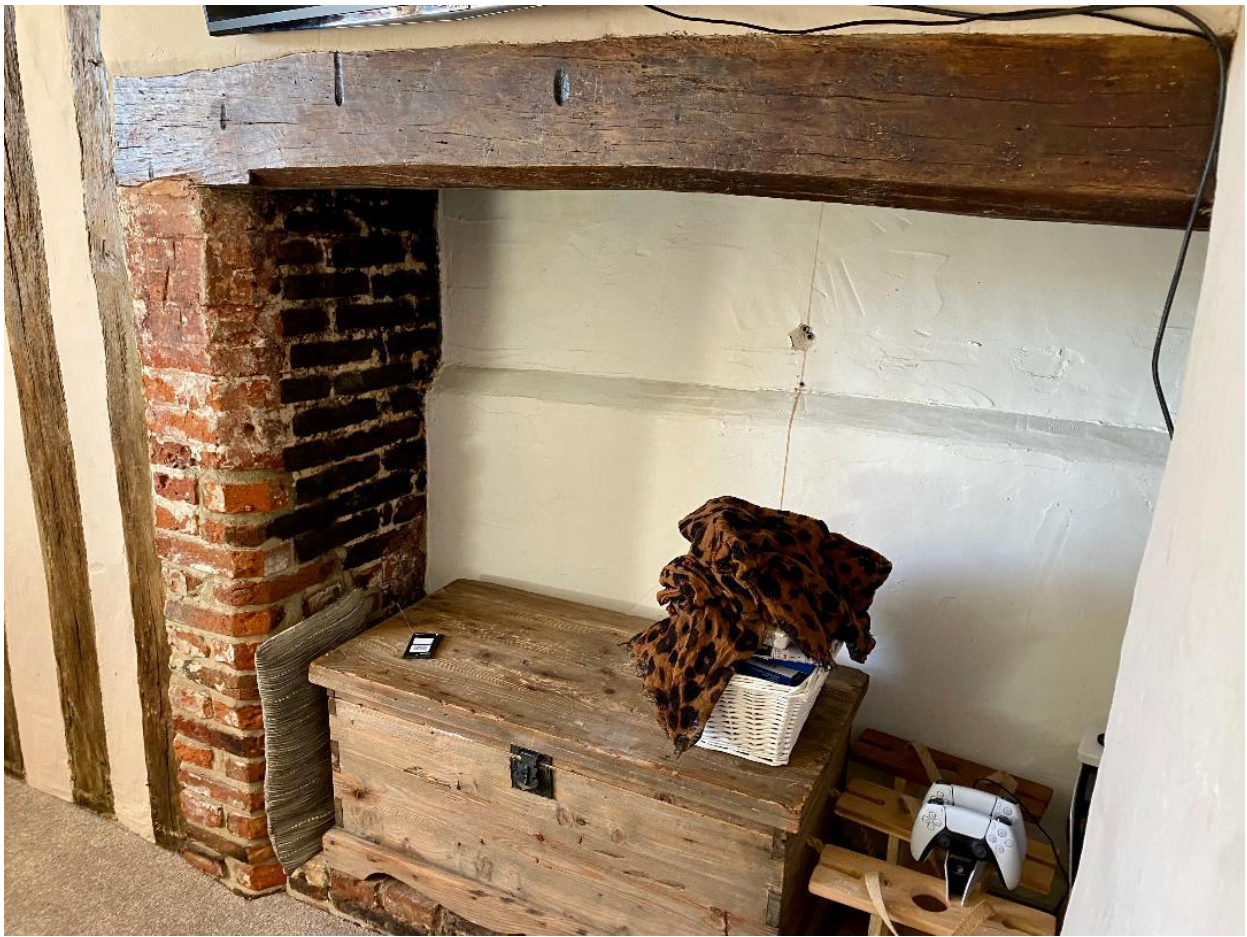
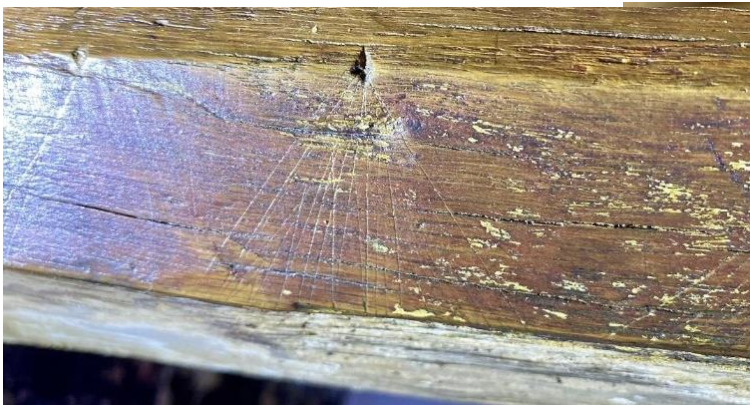
Upstairs, small bedroom south-facing fireplace. Door opening to vestibule, reputed to conceal a priest hole which was covered in fitted carpet so unable to verify. Two spectacle marks top right of the door frame going into the vestibule. Small bressummer with 4 burn marks, and fan-shaped cuts in the bevelled edge, about 13 in number.

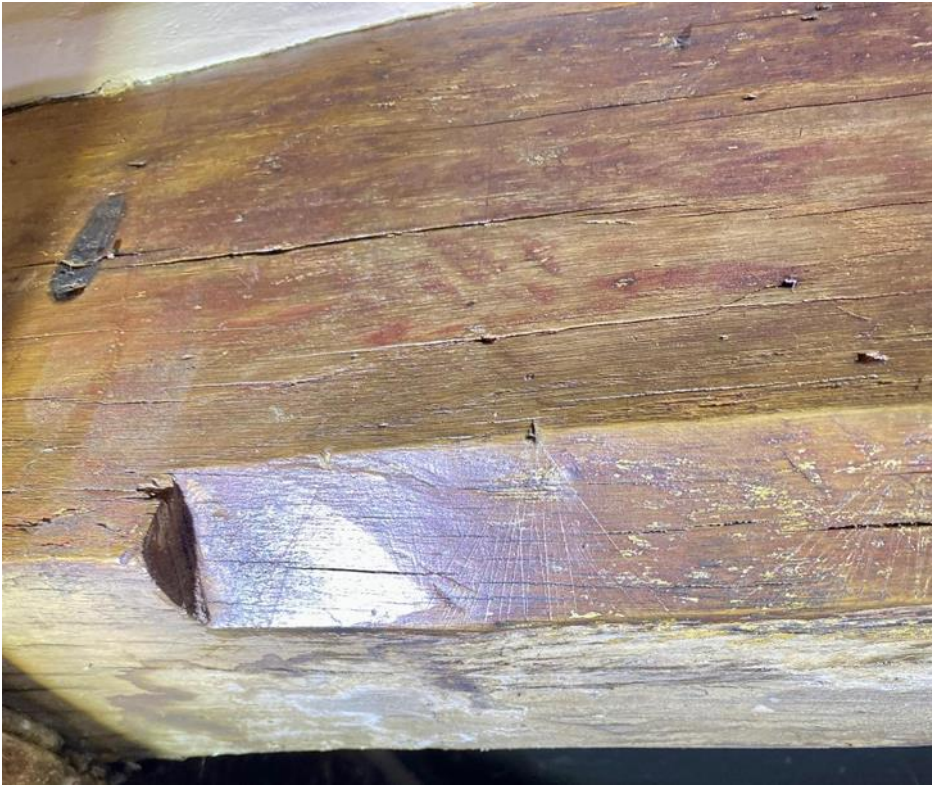
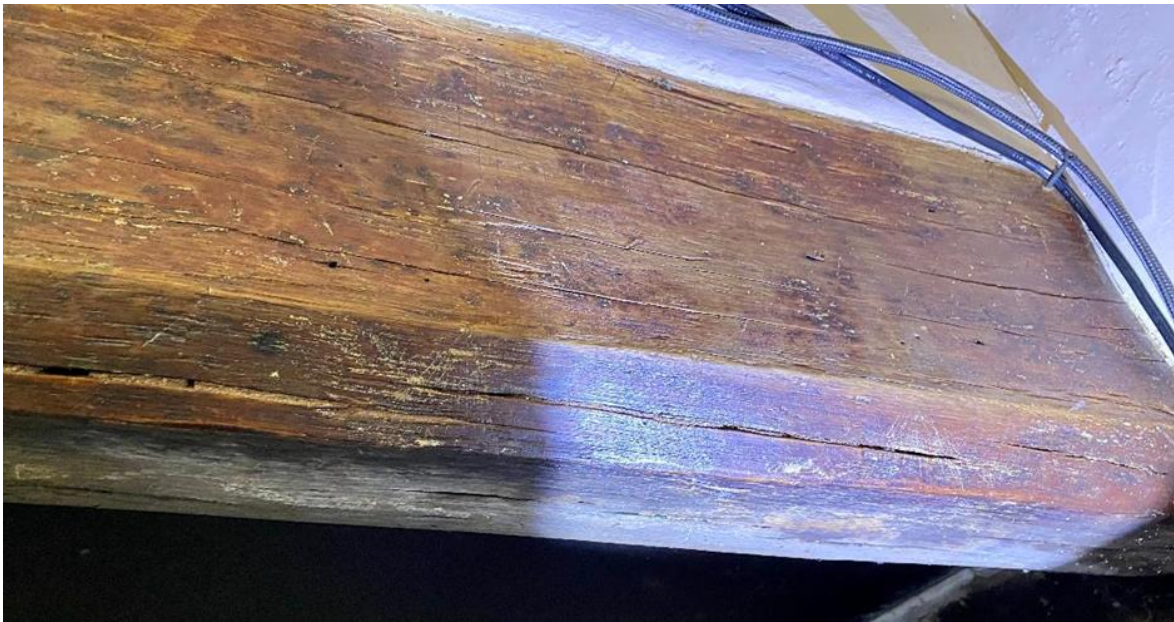
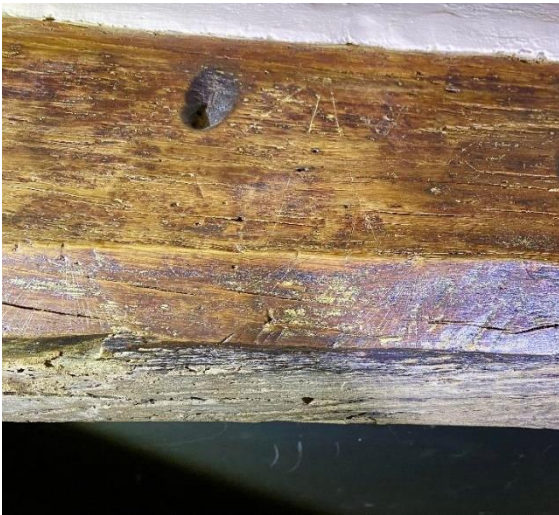
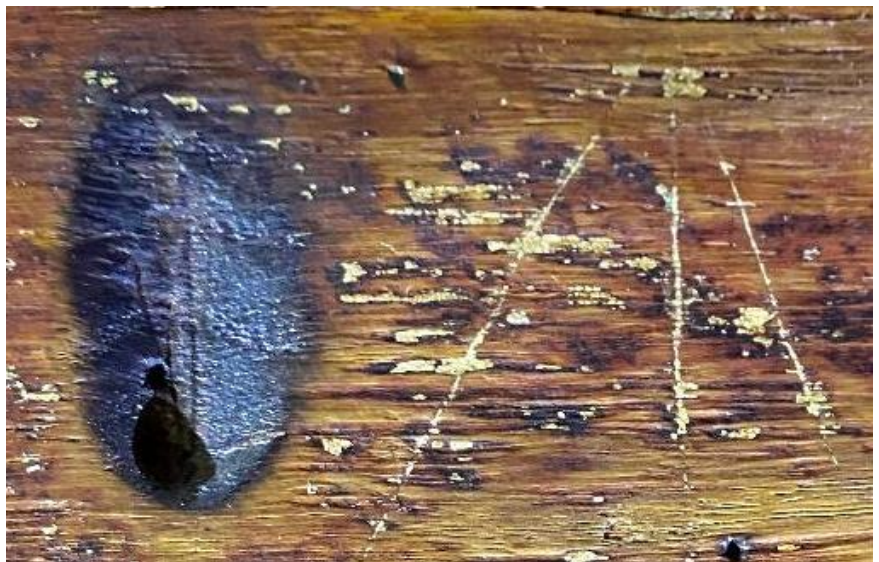
There are up to 13 fan-shaped cut marks which start at the same point for each fan and splay out on the chamfered edge of the bressummer. They are not evenly spaced.

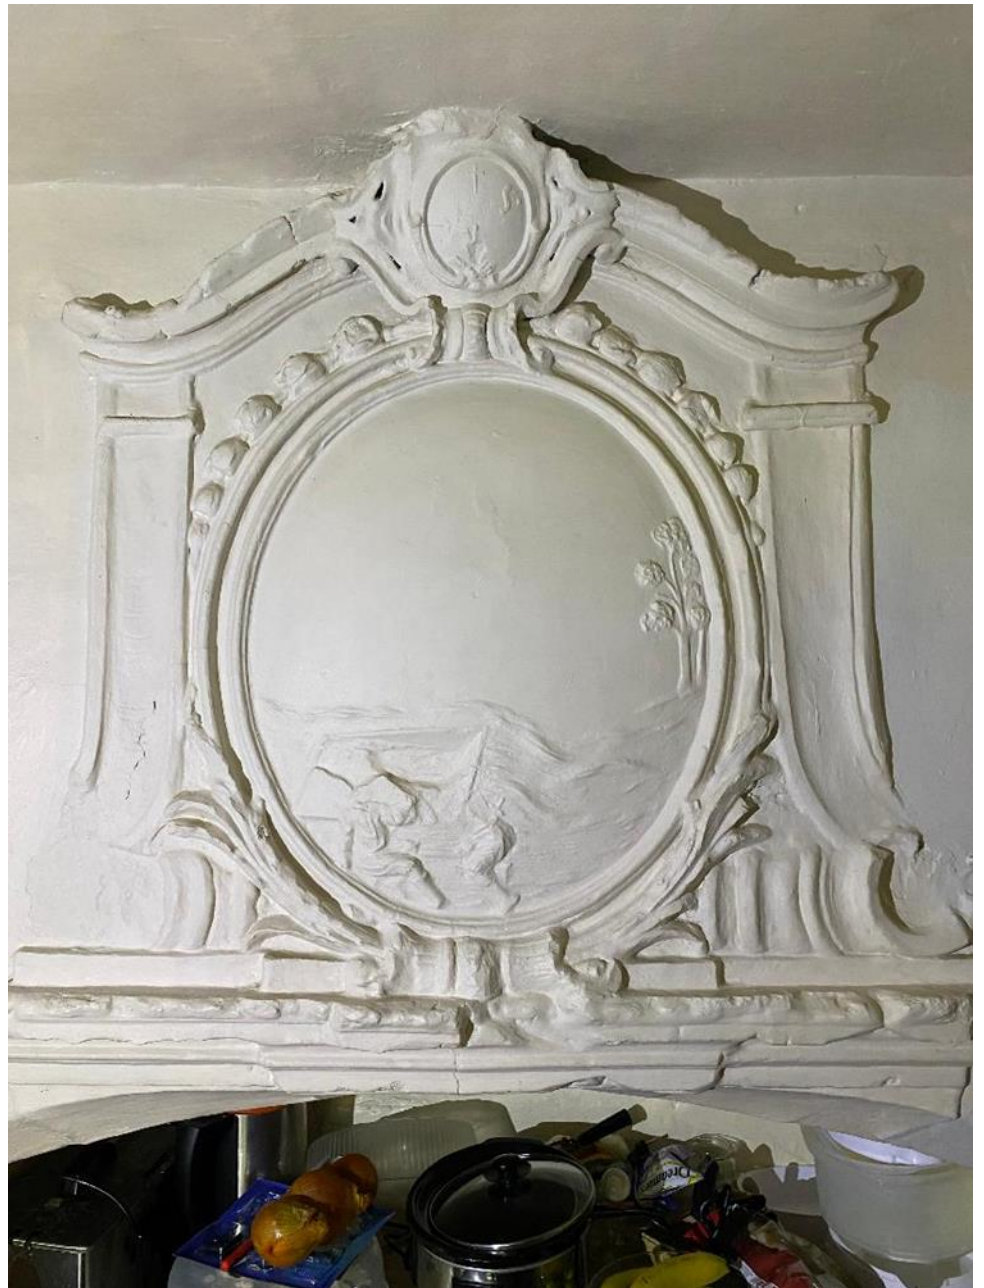
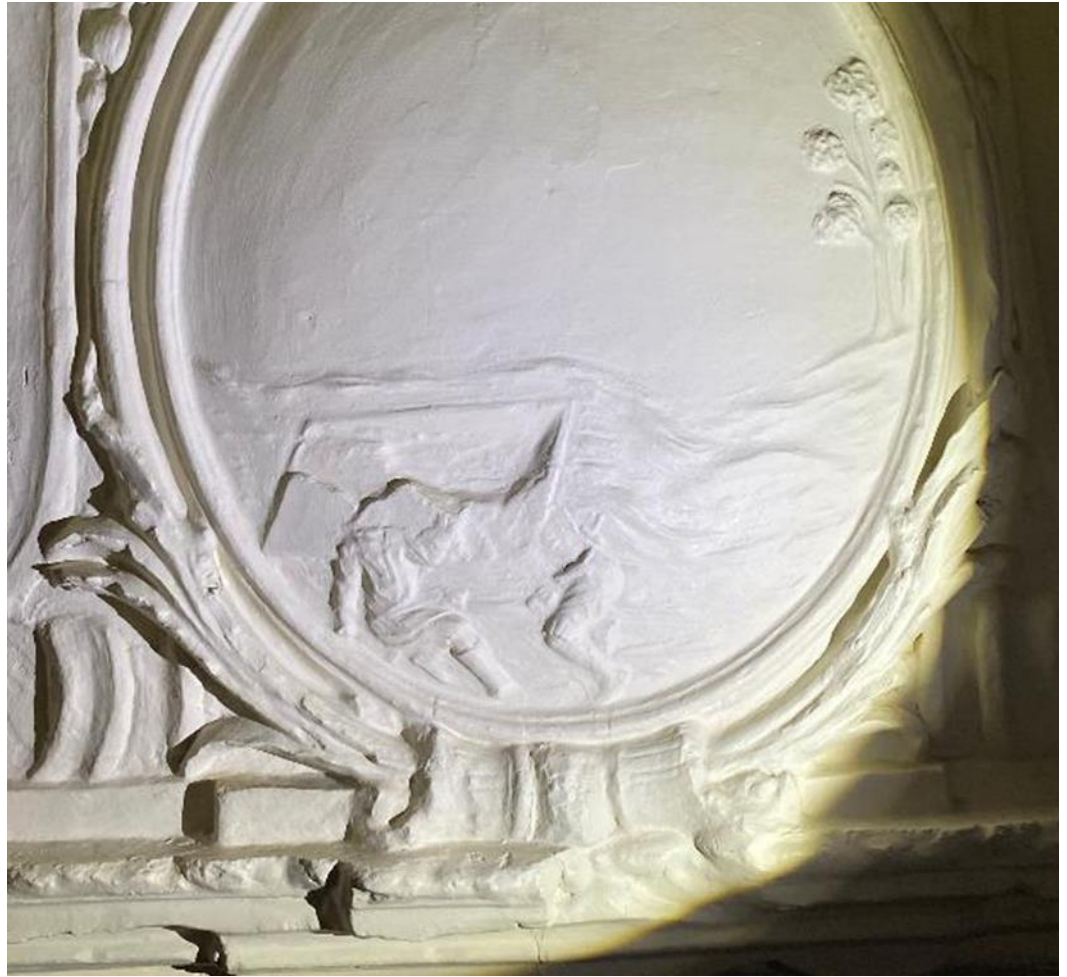
Scene of the resurrection, upstairs above a fireplace at the Swan, Hoxne

From the listing: A First floor room in former stair wing has a stuccoed fireplace over which is an early C18 plaster cartouche, the central oval tablet shows a Resurrection scene and above is a coat of arms which contained the sacred monogram IHS. This room is likely to have been a private chapel for a Roman Catholic family.

Certainly, the East facing cartouche suggests it could be a temporary chapel. The reputed priest hole on the other side of the chimney would have allowed either a quick get away for an illegal priest or somewhere to hide.

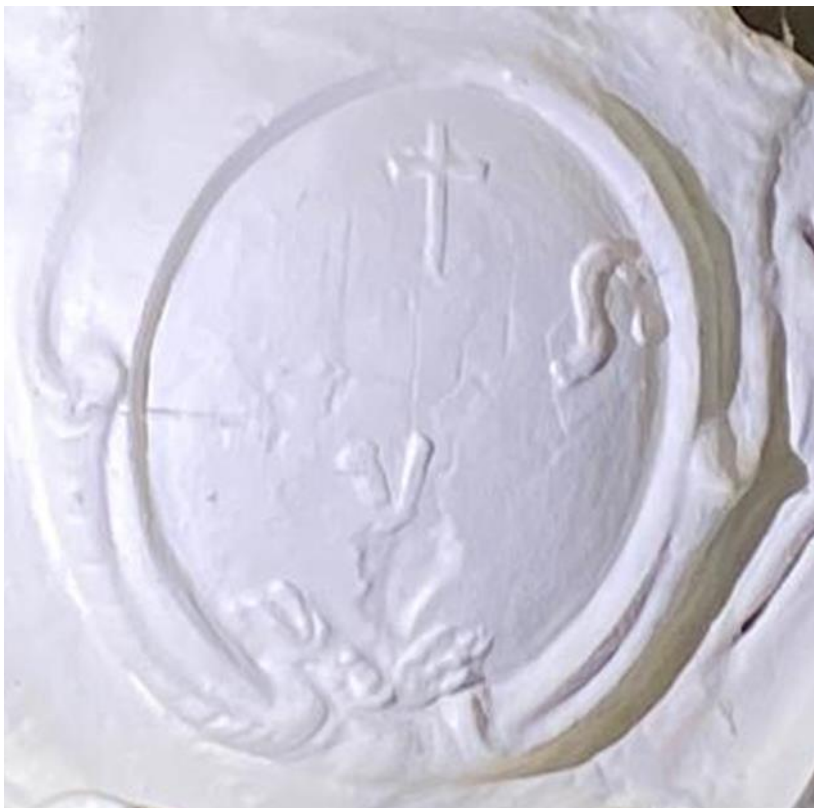
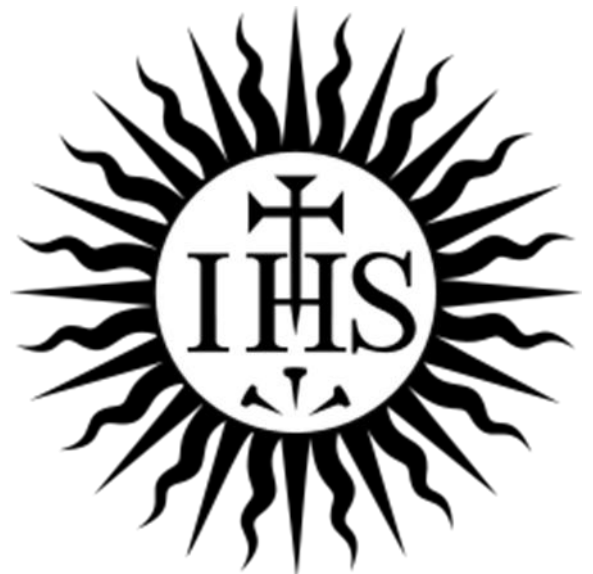
In Hoc Signo Vinces – In this sign, you will conquer

In the cartouche of the scene above the fireplace is a defaced monogram. It contains a remaining cross, S and what looks like a V. Having searched on the internet it is likely to be IHS with a cross and 3 nails below.

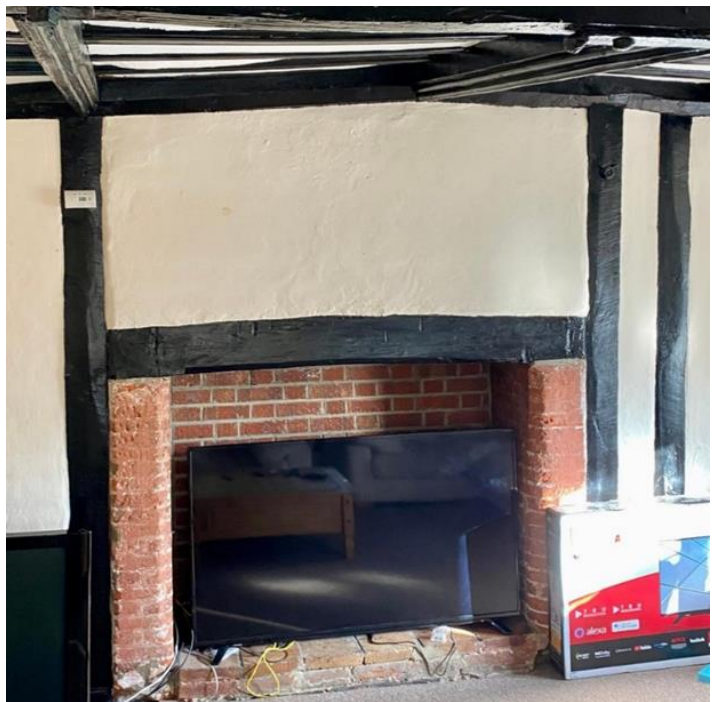
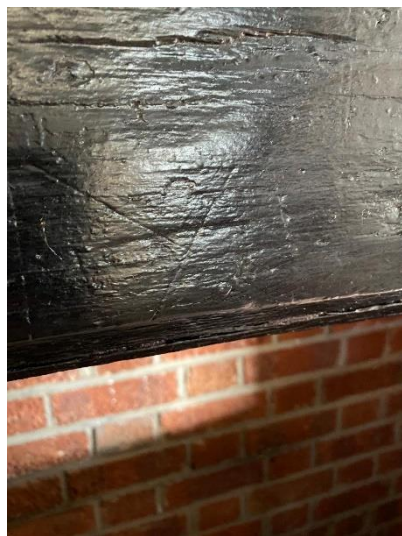
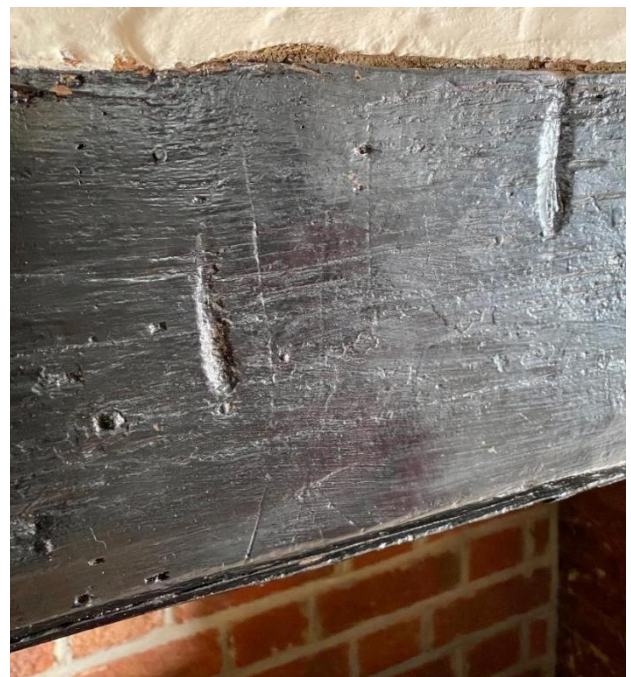
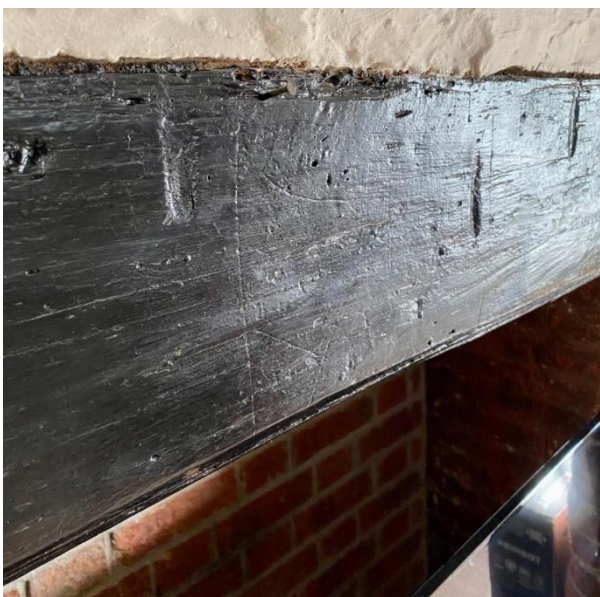
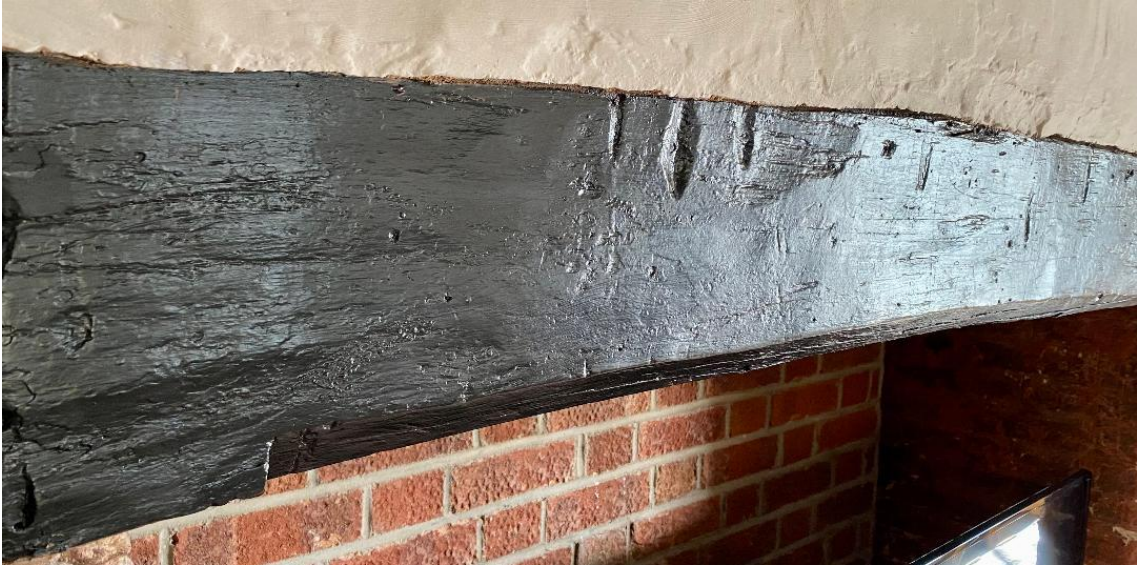
South side of the chimney

Large room, beams painted black (including the fireplace). Fireplace bressummer contains 10 burn marks, X marks and an M but much detail is obscured due to paint.

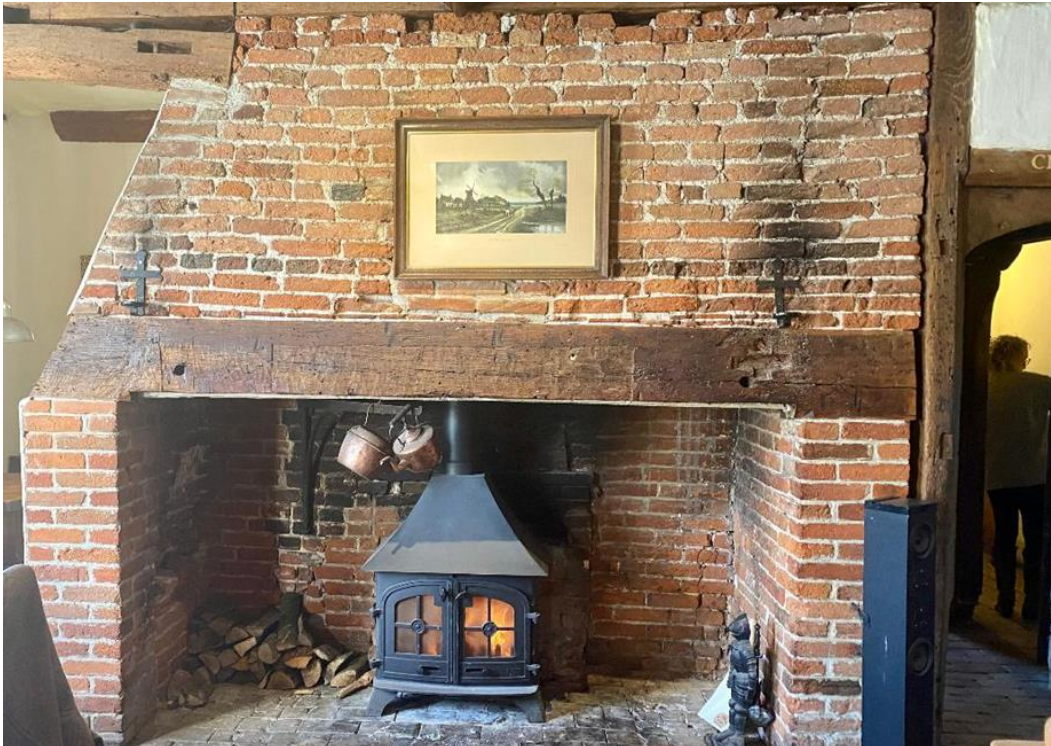
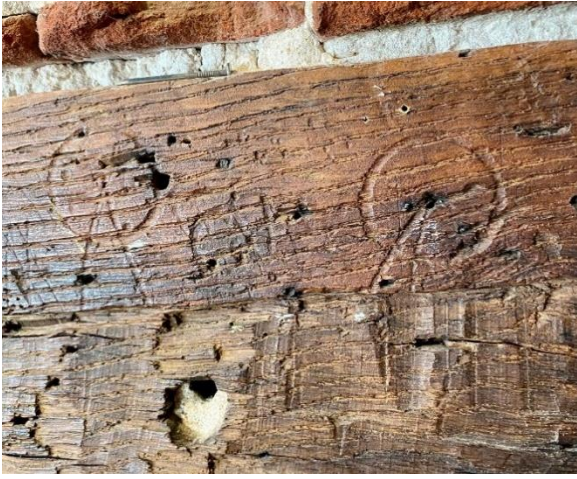
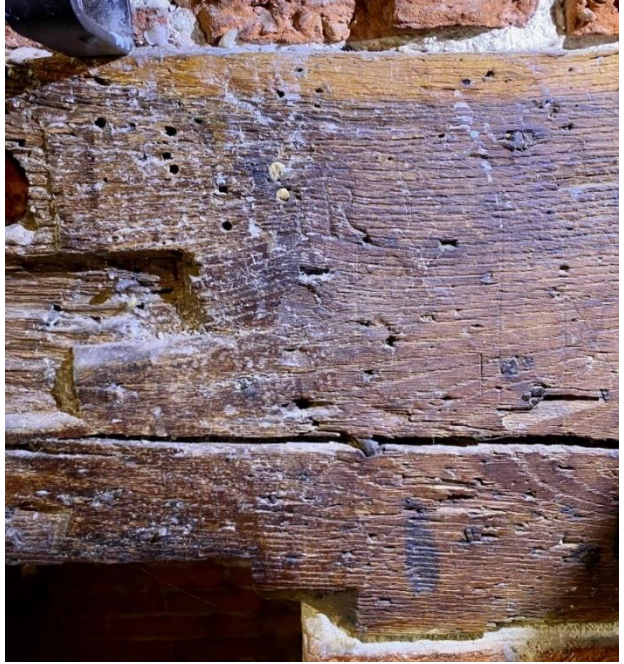
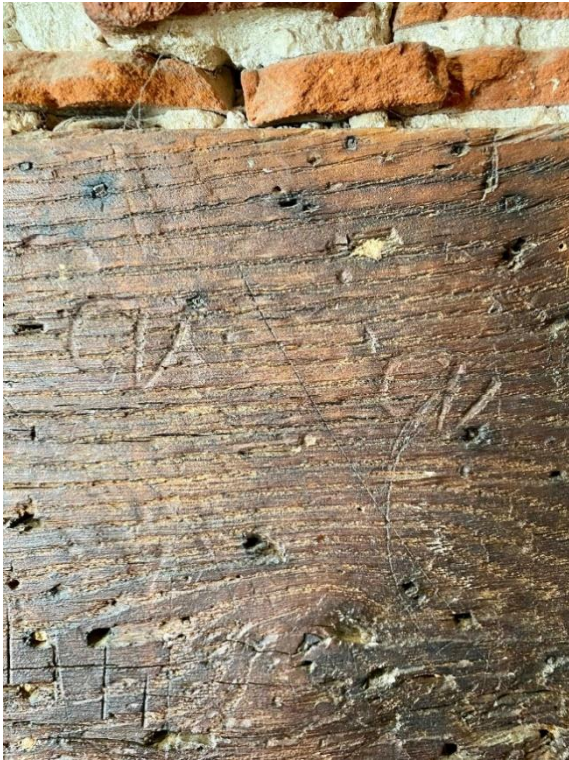
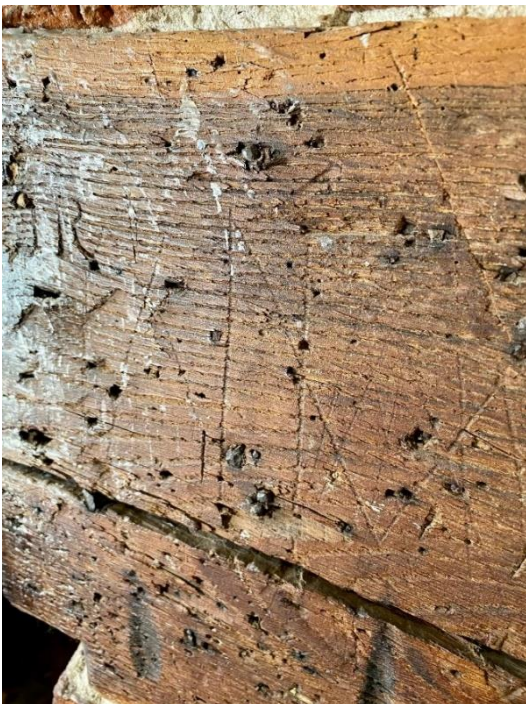
Downstairs, main bar north of chimney

Bressummer contains several burn marks (10+), three deeply carved and crude "M", on the West end of the beam behind the deeper and crude M are a finer and shorter interconnected M and possibly A. There are a few arcs of an incomplete compass drawn circle and two clear, deep circles both cut by an inverted "V" shape. The central part of the beam has been cut away to accommodate a new fire surround in the 20th century. The finer, more complex M is likely to be 16th Century and the others 17th century and later. There are also a number of burn marks on door frames downstairs and behind the bar.
