## Architectural Description of 22-24 Low Street, Hoxne, Suffolk

Map ref: Tm 181773

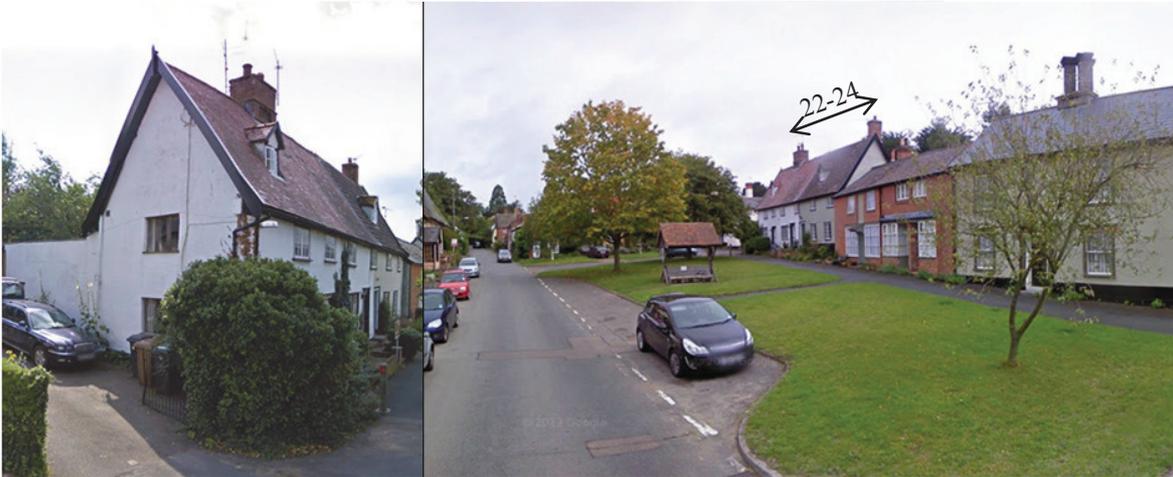
Fig 1: 22-24 Low St - left from the north and right from the south

22-24 Low Street which sits on the edge of the green in Hoxne, Suffolk, is a fairly complete late 15<sup>th</sup> century medieval hall house of which the central room, the hall, was open to the roof and heated by an open hearth (Fig 1). The hall is now mostly occupied by No 23. In the 16<sup>th</sup> century the hall was floored over and a chimney inserted, replacing the open hearth. In the 18<sup>th</sup> or 19<sup>th</sup> century single storey outshots were added along the back of the house and an additional chimney added at the right hand (south) end of the house. At some stage it was divided into three separate houses as shown in Drawing 2.

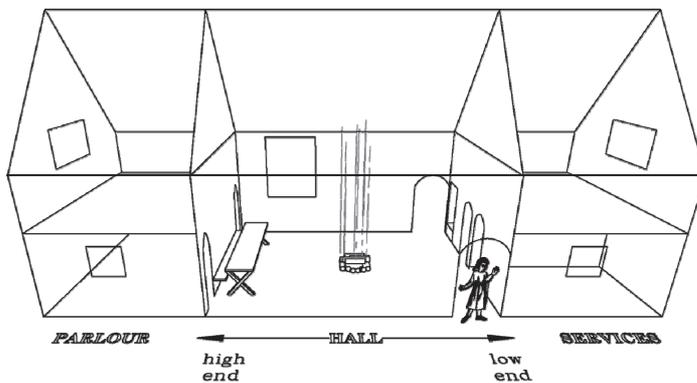
Fig 2: Layout of a 'standard' medieval house in East Anglia

Medieval houses of the 14<sup>th</sup> and 15<sup>th</sup> century had a fairly standard layout with a hall open to the roof at the centre. The entrance to the house was at one end of the hall, called the low end. At the other end of the hall, the high end, there was a large window lighting the hall and the high table. Beyond the high end was usually a single room, called the parlour, normally with a chamber above, while beyond the low end it was divided longitudinally into two service rooms with a single chamber above. These two rooms were entered from doors in the middle of the low end wall of the hall (Fig 2).

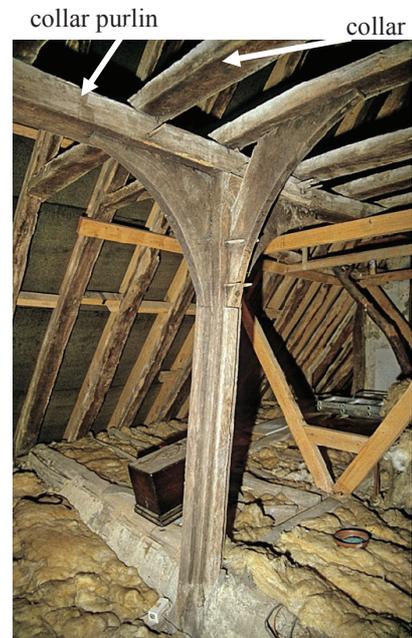
Fig 3: Crownpost on centre truss of open hall at Railway Terraces, Wenhaston, Suffolk

The building is 58ft long, longer than most medieval hall houses, mainly because it has an exceptionally long service end. The hall is 24ft long, not especially long but at the upper end of the range, and was of two almost equal bays. It had a crownpost roof - an example of which is shown in Fig 3. Here each pair of rafters is joined by a collar which are supported by a long horizontal timber running under the collars, called a collar purlin, that is carried by the crownpost. Most of the rafters survive, heavily smoke blackened from the medieval open hearth, but the central tiebeam and crownpost have been removed (Fig 4). In the north (high) end bay of the hall the timber framing of the rear wall is fully visible and the mortices for the diamond mullions of the large medieval high end window can be felt under the wall plate.

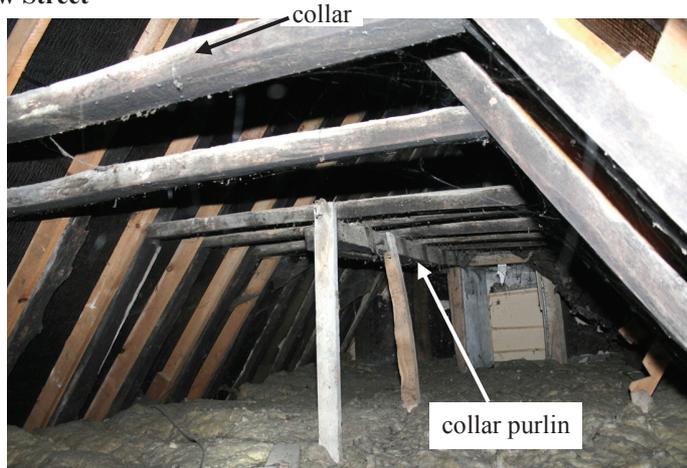
Fig 4: Heavily smoke blackened roof over the hall of 23 Low Street looking south. The crownpost has been removed and the collar purlin truncated.

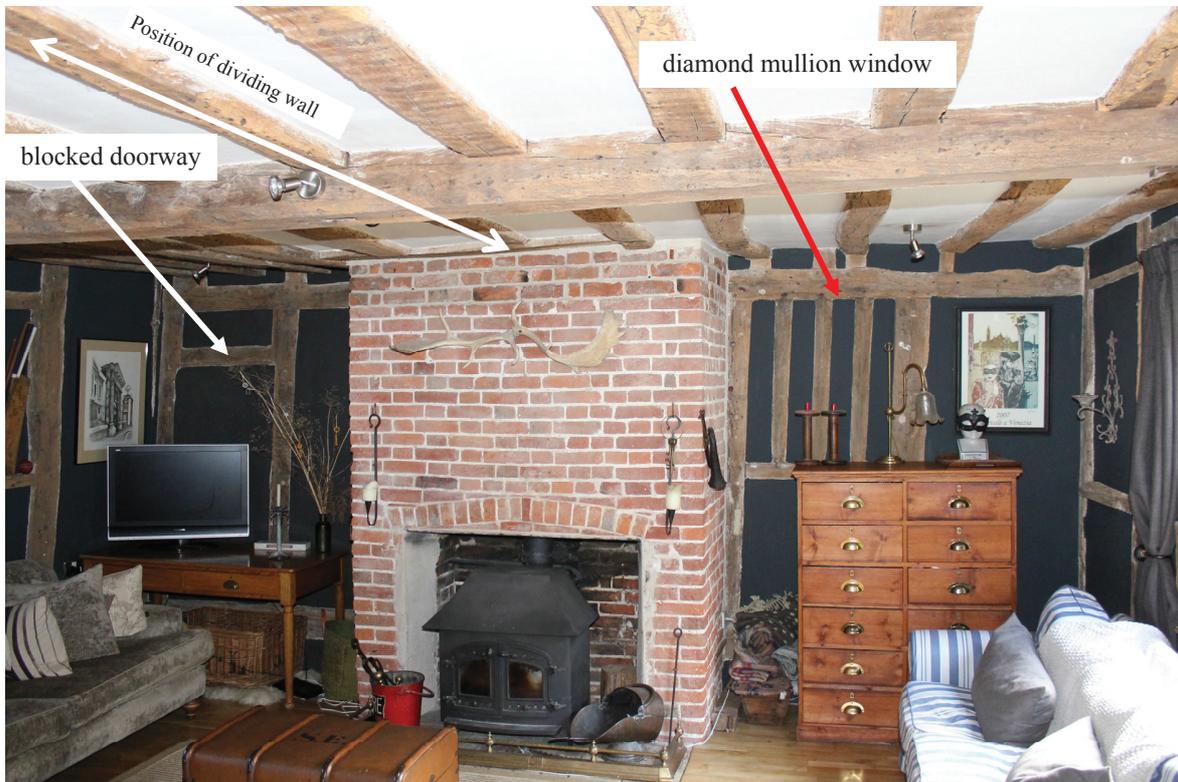
Fig 5: South wall of service bay.  
*the partition between the two rooms has been removed and the chimney stack inserted in the 18<sup>th</sup> or 19<sup>th</sup> century*

The service end is long, 19ft compared to 10 to 13ft for a majority of such houses (Drawing 1a), and is divided into two bays because of its length - usually they have just one bay. It was divided longitudinally into two rooms with a single chamber above as is usual, but the rear ground floor service room had an external doorway in the south gable, very much a non standard feature (Fig 5). This door may have gone to a detached kitchen or possibly a separate workshop. Today there is another house built against the south wall (Fig 1), but originally there was an open space as there is a diamond mullion window, now blocked, in the south gable lighting the front service room (Fig 5).

It is not known why the service end was so long, or what the two ground floor rooms were used for. The front service room has a large number of windows, three in all; a diamond mullion window in the south gable - with its mullions still in situ (Fig 5) - and two tall windows in the front, west, wall (Fig 6 and Drawing 2c). It is not known if these two tall windows had diamond mullions like all the other windows. It is possible they were open and this front service room was some type of workshop. It is not possible to tell today.

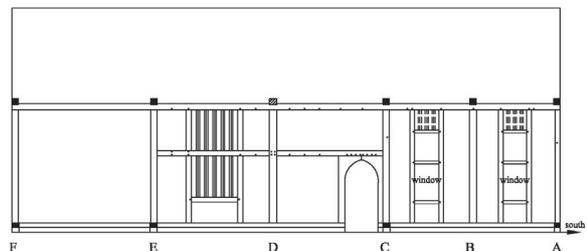
Fig 7: Reconstruction of exterior appearance of the medieval front wall

The hall has close studding framing with the studs spaced at 1ft 7 to 1ft 9in centres and has a mid-rail dividing the studs, while the service end has full height studs rising from the ground cill to the wall plate and spaced much wider at 2ft 9in to 3ft 3in centres. This variation could not be seen externally as most of the timbers were plastered over on the outside with the only timbers visible being the main posts, mid-rails, wall plates, doorframes, the studs either side of the windows, window cills and ground cills (Fig 7). The common studs are 3¾in deep and set back 1¼in from the external face of the wall plates, mid-rails and principal posts, while the studs framing the large hall window and the windows in the service end are 5in deep and set flush with both the internal face of the common studs and with the external face of the wall plates, mid-rails, etc. Evidence for this can be seen in the rear wall of the open hall in No 23 where on the first floor the infill between the studs has been removed on the north side of the opening for the large medieval hall window, revealing the depth of the common and hall window studs. This type of framing with the exterior mostly plastered over seems to appear in the second half of the 15<sup>th</sup> century and is a common feature of north Suffolk and Norfolk.

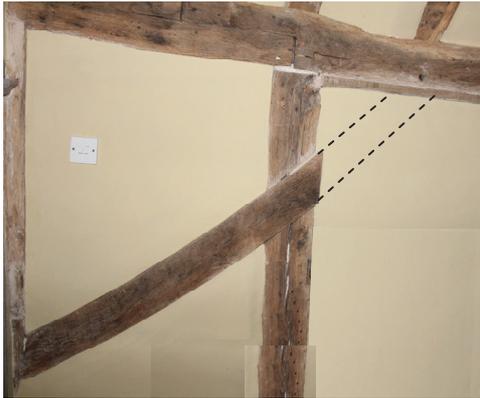
Fig 8: Convex or drooping brace in 24 Low Street

Braces are convex, or drooping, half the thickness of the studs and halved across the internal face of the studs, and thus are visible only inside the building (Fig 8). The service doors and the external entrances into the hall were durn doorways, that is where the two door jambs are bent at the top to form an arched door head (Fig 9 and Drawing 2a). These doorways are common in north Suffolk and Norfolk up into the 16<sup>th</sup> century, whereas in south Suffolk they are relatively rare after 1400. However the doorway in the south end wall of the rear service room of 24 Low Street, and probably the one in the north wall of the hall into the parlour, are the more convention type made up of the two door jambs and a separate arched head. These doorways with separate arched heads are the common form in south Suffolk, less so in north Suffolk.

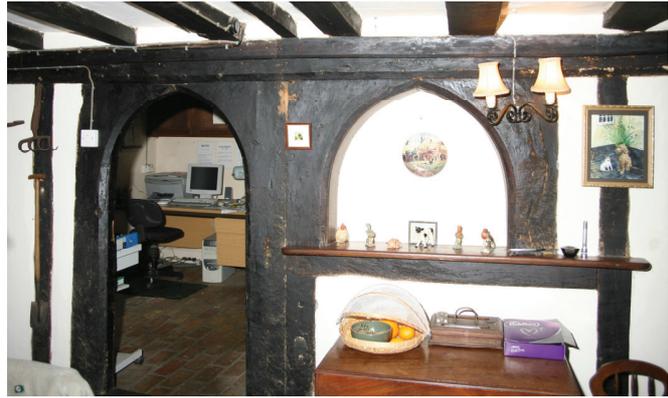
Fig 9: Durn doors at Broad End Farm, Stradbroke, Suffolk

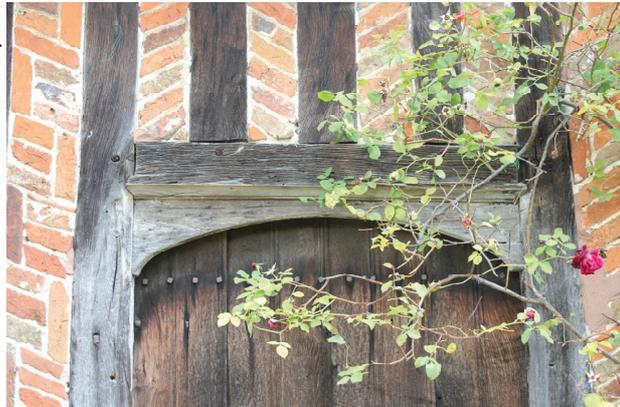
Fig 10: Arch headed door in Abbey Farmhouse, Hoxne

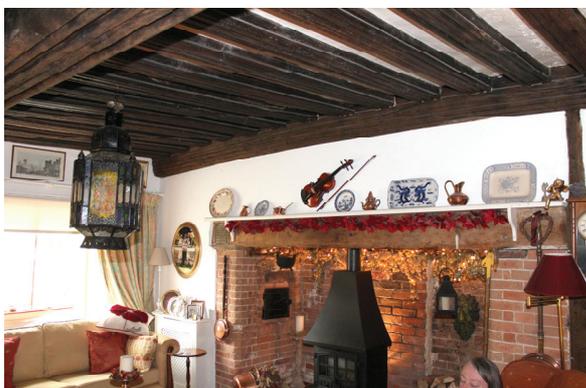
Fig 12: Fireplace inserted into hall

In the 16<sup>th</sup> century there was a major change in the way people lived with the open hearth being replaced by a chimney. 22-24 Low Street was modernised by the insertion of a chimney at the upper (high) end of the open hall and, either at the same time or possibly a little later, the hall had a ceiling inserted creating a first floor over the old open hall (Figs 12 & 13). The chimney

stack had fireplaces on the ground floor heating the hall and the parlour, and most likely also heating the parlour chamber in what is now No 22 and which has not been examined.

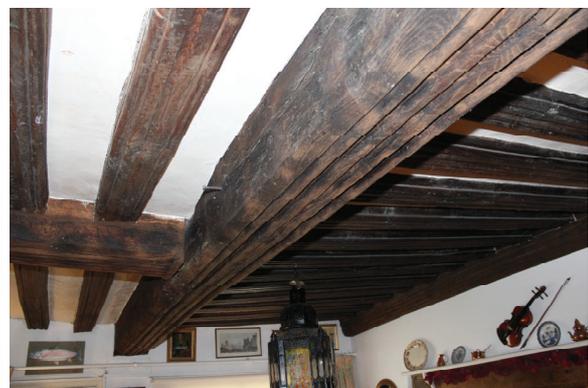
Fig 13: Inserted hall ceiling

The ceiling inserted into the hall is heavily moulded (Fig 13) with multiple rolls on both the main joists and the common joists. All of it is constructed of relatively large timbers, including the common joists which are also fairly large. It probably dates to the first half of the 16<sup>th</sup> century, though it could be a bit later in the third quarter of the 16<sup>th</sup> century. Towards the end of 16<sup>th</sup> century the mouldings tended to become more subdued. The ceiling in 22-24 Low Street is unusual in that the common joists in upper bay of the hall run longitudinally while those in the low end bay run axially across the building. Usually the common joist run in the same direction in both bays (Drawing 1b).

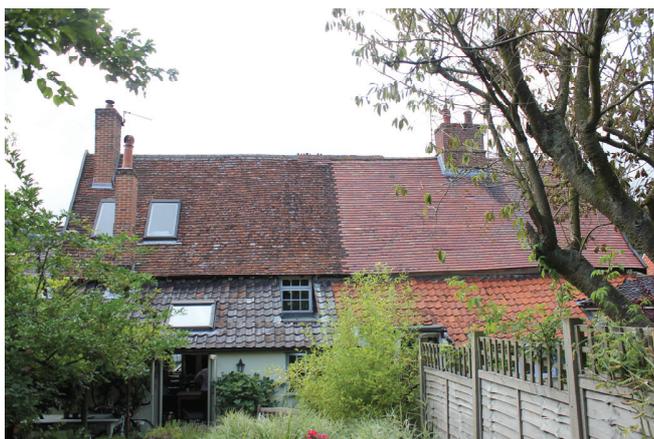
Fig 14: Rear of 24-22 Low Street, Hoxne

At some stage attics were inserted over the parlour and service chambers with the collars removed to create more headroom - previously these upper rooms were open to the roof - and a single storey outshot was added along the whole of the rear wall. This was not examined to see if this was added in a single building phase (Fig 14). In the 18<sup>th</sup> or 19<sup>th</sup> century a chimney was added at the south end of the building to serve the now single service room. This may have been done so this room could become the kitchen. Or it may have been done when the building was divided into three separate dwellings as it is today. The division is interesting as today the central unit has not only most of the old open hall other than the crosspassage, but also the attic over the parlour chamber and the cellar under the service room as shown in Drawing 2c.

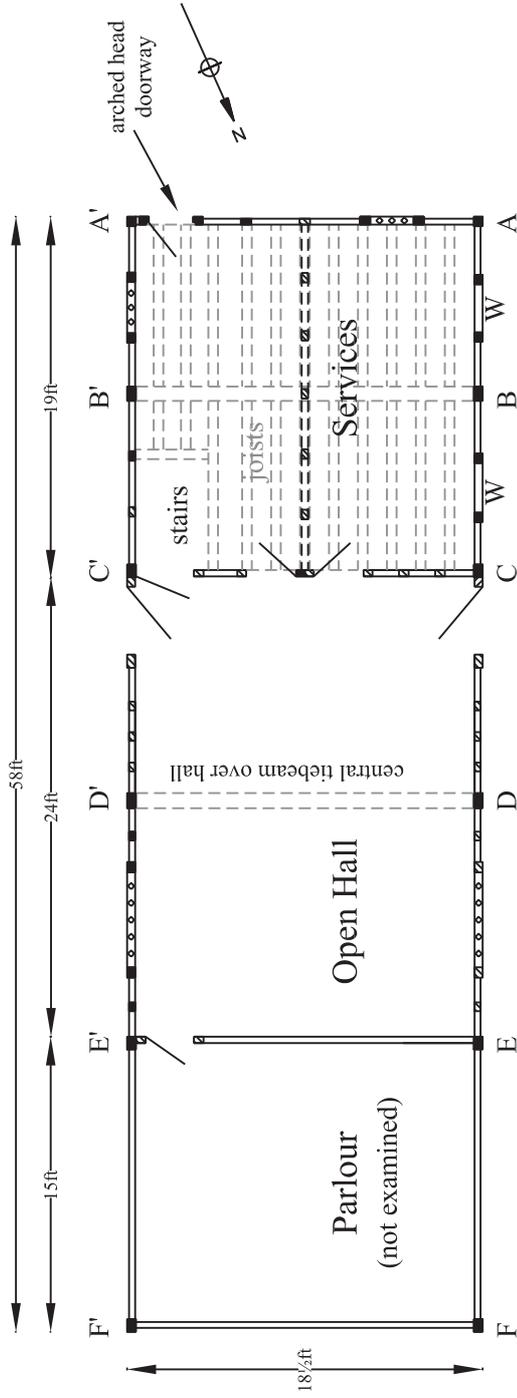
**Drawing 1: Plan of 22-24 Low Street, Hoxne, Suffolk**

a: Reconstruction of original ground plan of open hall house

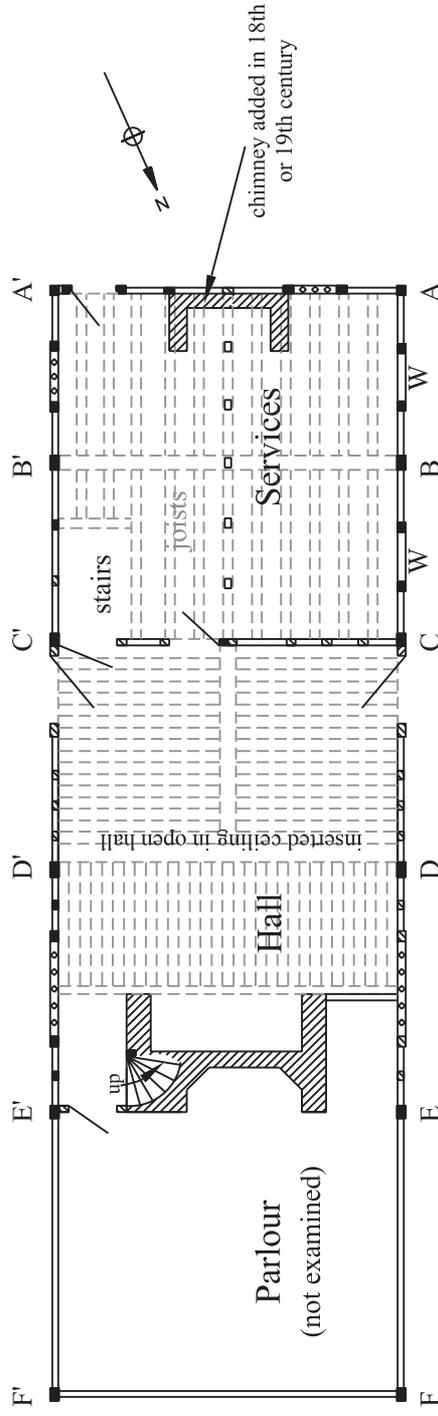
b: Reconstruction of plan in early 16th century after chimney and ceiling inserted into the open hall.

At the same time, or a little later the two service rooms would have been combined in to a single room. The chimney at the south end of the service room was inserted in the 18th or 19th century and during this period lean-to outshots (not shown above) were added along the rear (east side) of the building.

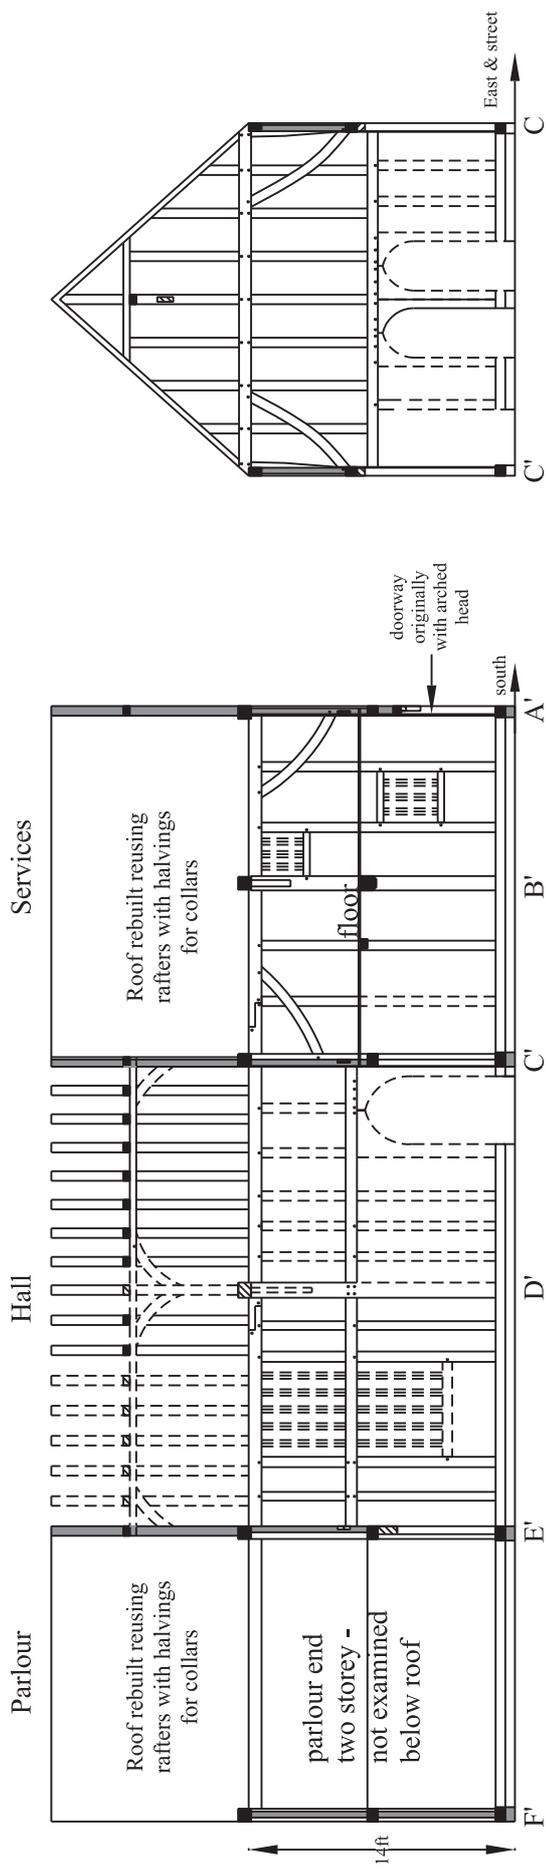
## Drawing 2: Reconstruction of elevations and a section of 22-24 Low Street, Hoxne, Suffolk

a: Reconstruction as built of rear wall viewed internally

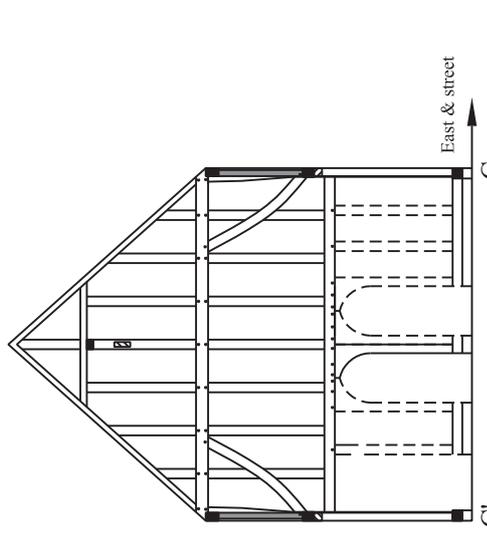
b: Reconstruction as built of partition at south end of open hall viewed from within hall

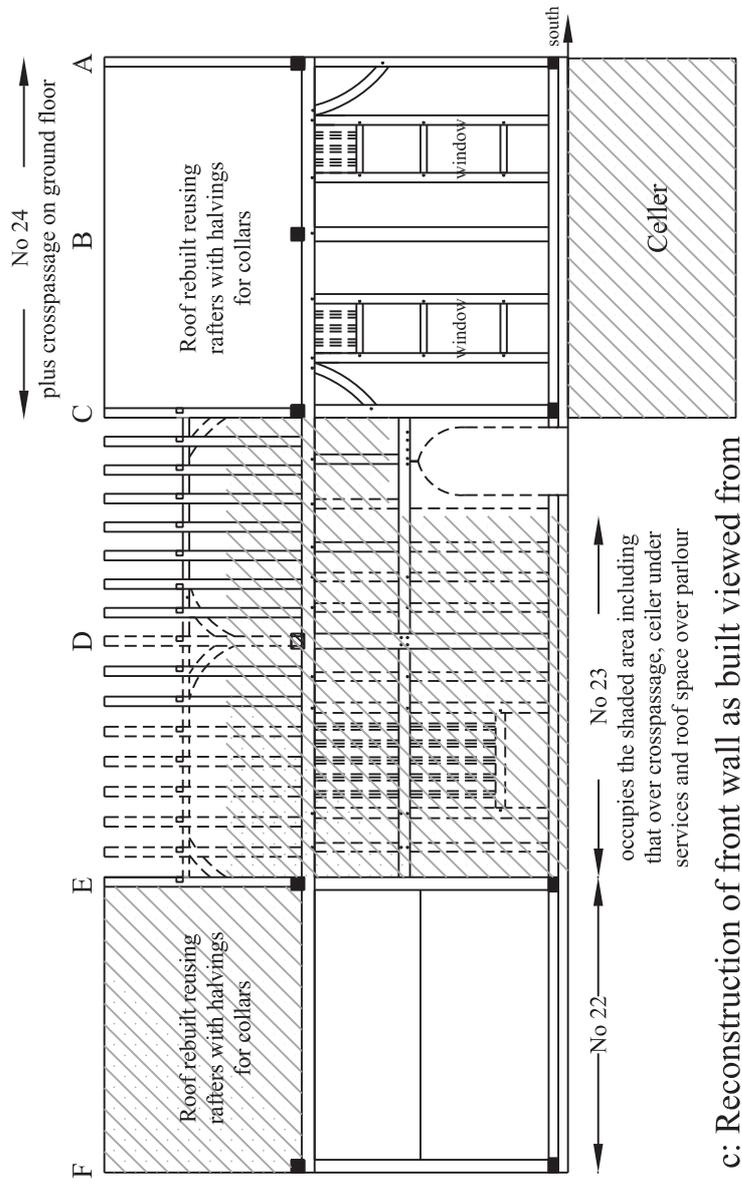
c: Reconstruction of front wall as built viewed from exterior and how building now divided into three houses

There is a cellar under the service end. This could be an original feature but equally it may be a later insertion. It is now occupied by the house next door, No 23 (see Drawing 2c).
