Aldersyde cottage 2.2.22

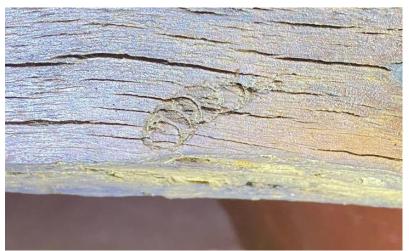
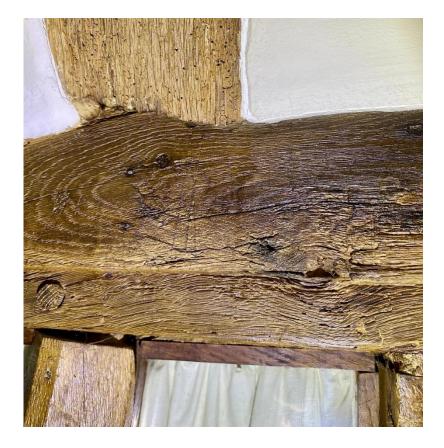
Ground floor, north room. On the 18th century inserted chimney is a bressummer containing 5 interconnecting circular punch marks 2cm long on the bevelled edge of the beam. In a number of places are roman numerals used by carpenters and builders when the house was constructed in the 16th century.
