**Gissing farm 7.12.21** (Drawings and some photos taken from work done by Pauline and David Rimmer previously)

GISSING FARMHOUSE, SOUTH GREEN, HOXNE SUFFOLK

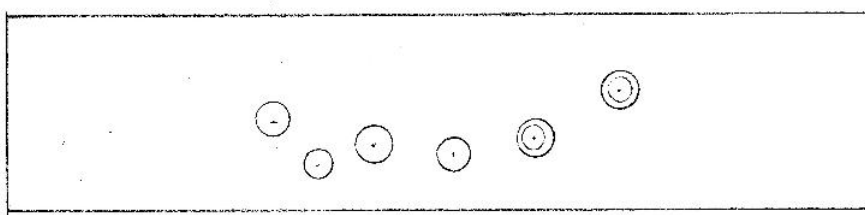
Cross Passage Ceiling

Circle diameters between 7 and 9 inches

Much work already done by Pauline and David Rimmer. A number (6) of compass drawn circles in the plaster in the ceiling of the cross passage (see diagram) up to 26cm in diameter. On the 16<sup>th</sup> century planked partition from left to right: compass drawn circles within each other (5 circles) 15cm. To the right of the door, daisy wheel 10 cm diameter, 6 point "star". Large (20.5cm wide) "W" with curved base and horizontal lined top. On the beam which would have contained the second partition of the cross passage there are a number of marks which are in part carpenter's marks. The plaster work above the cross passage is likely to pre-date major alterations carried out around 1794 when one partition of the cross passage is likely to have been removed.

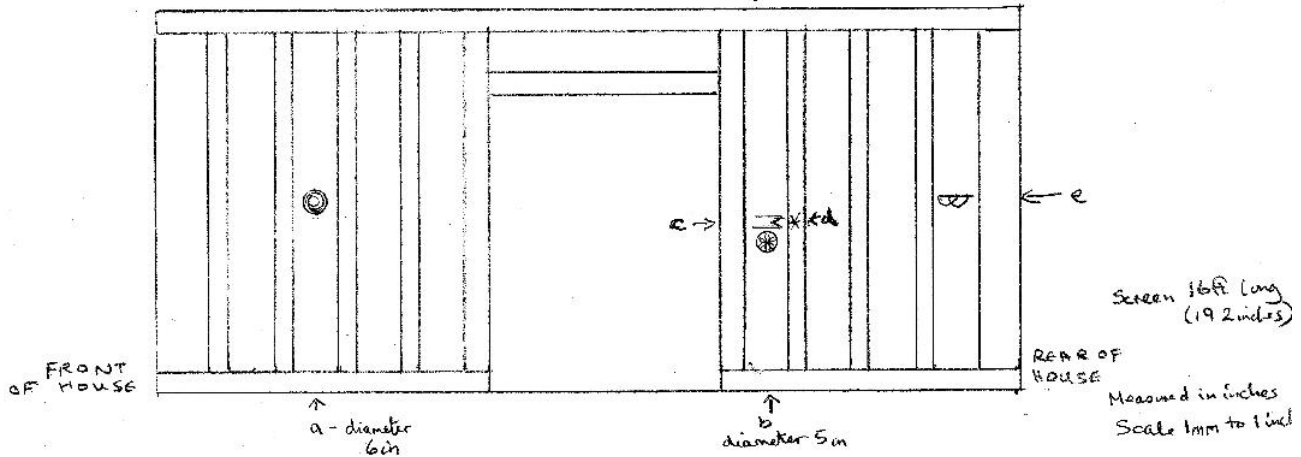
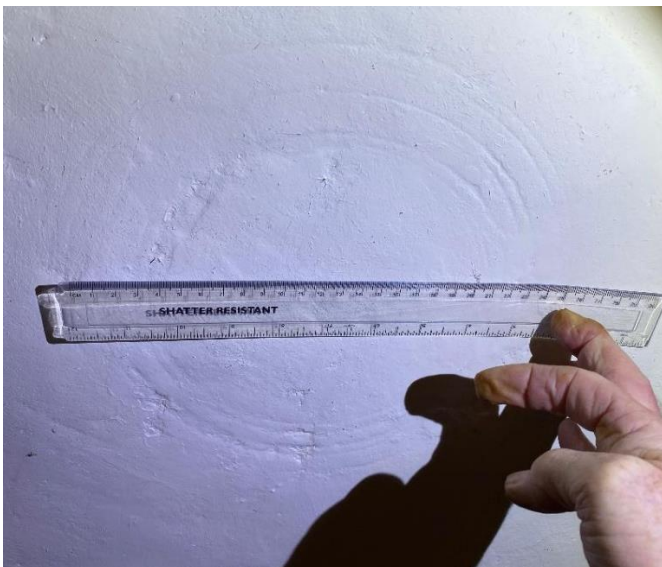
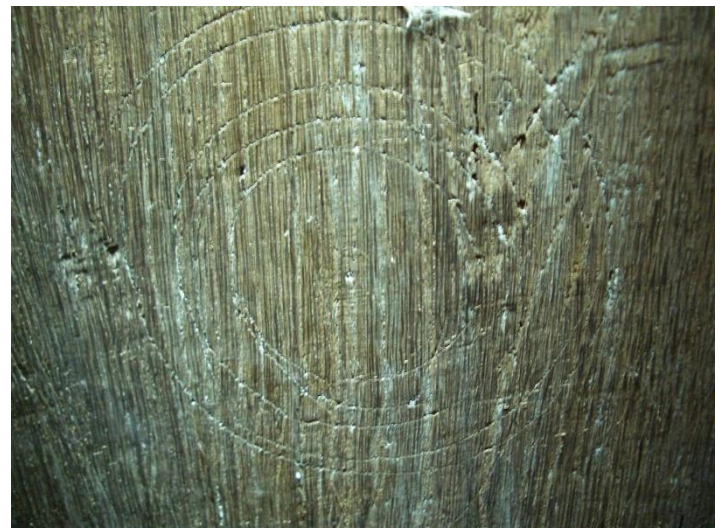
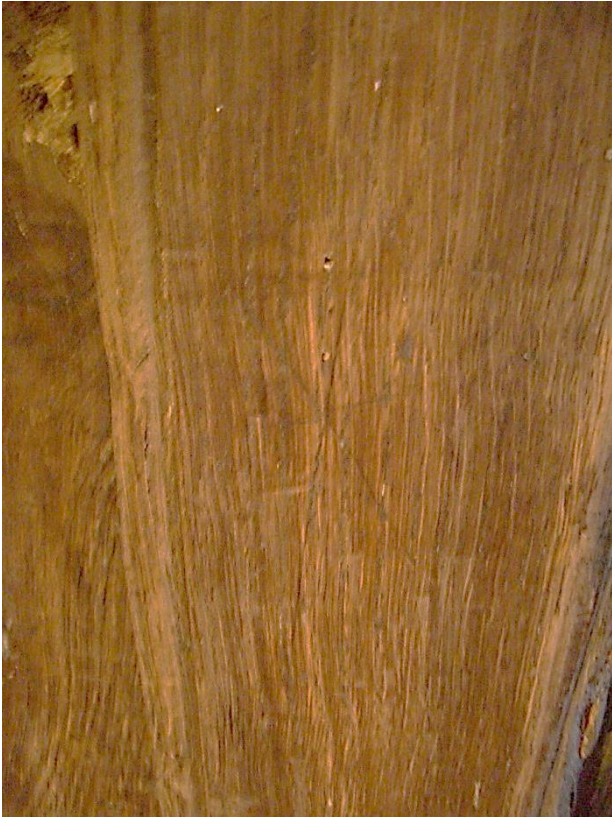
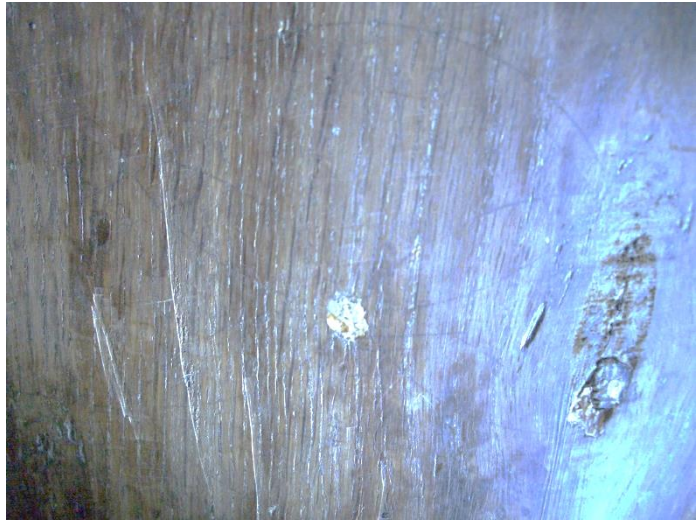
Planks and Muntin Screen facing Kitchen (Hall side of cross passage)  
(Hall side of screen plastered over)

Much of the marking is from compass drawn circles in the area of the cross passage. Star (\*) pattern and daisy wheel on the partition. There is one "W" on the partition of the cross passage and possibly one MR in the dairy on the central ceiling beam. Three taper marks on the bressummer in the west first floor bedroom.

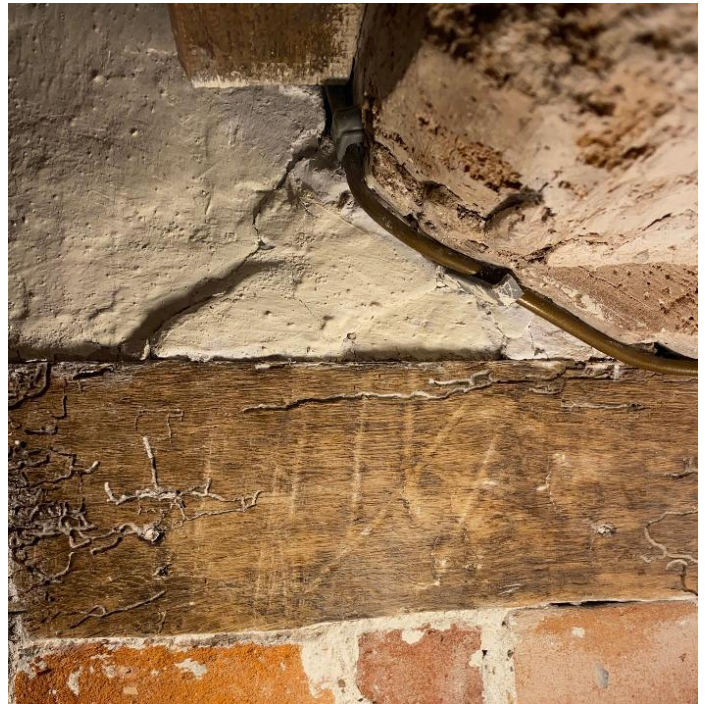
Dairy, ground floor – central beam.  
Carpenter's marks but also MR

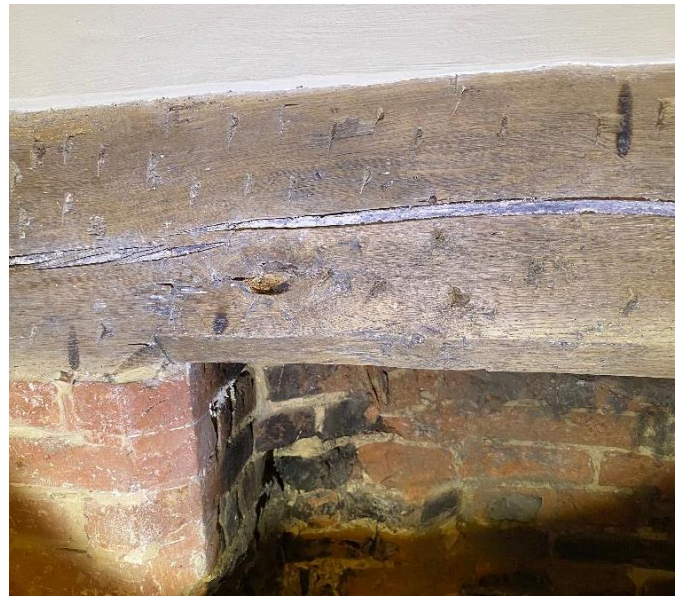
First floor, west bedroom, fireplace

Three taper marks. Marks for attaching later plaster. Some scratches, no clear pattern or frequency.

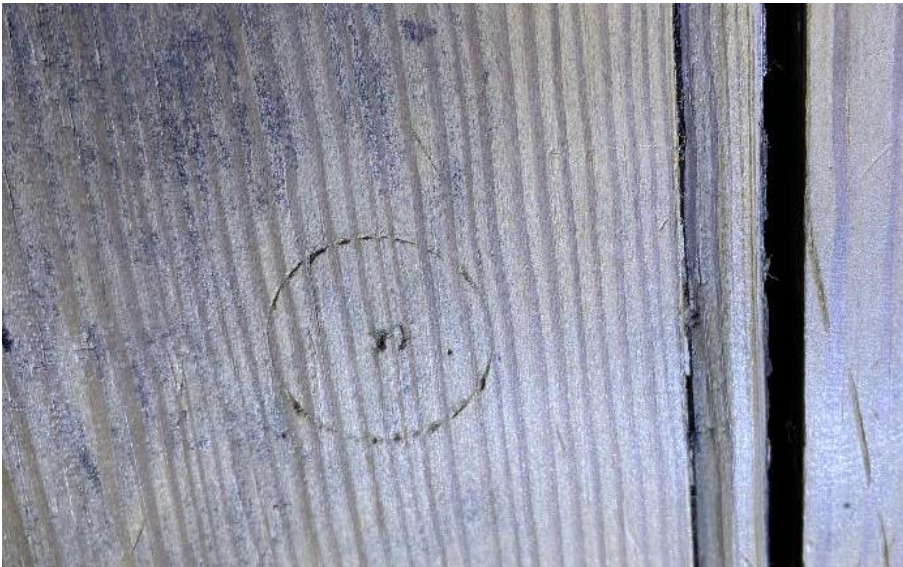
Ground floor, Victorian door

2cm diameter, compass drawn circle on the door which is Victorian and dates the mark as Victorian or later.
